**Accident Investigation Board
Denmark**

FINAL REPORT

HCLJ510-2011-43

Accident to De Havilland DHC 8-106
Registration TF-JMB
Nuuk Airport (BGGH), Greenland
The 4th of March 2011

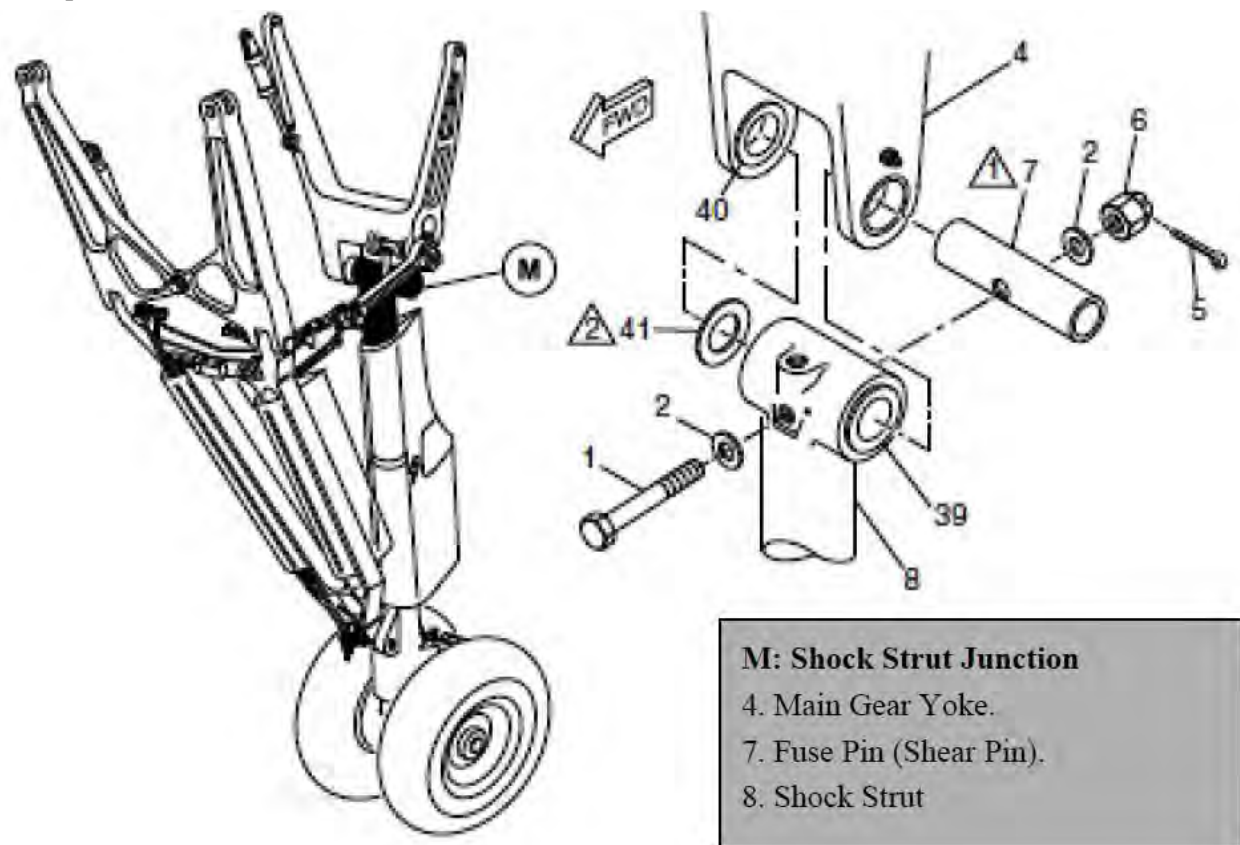
1.6.3.2 Fuse pin and Joint Aviation (JAR) requirement

To prevent the gear from rupturing the fuel tanks inside the wing box during a rough landing, a fuse pin (shear pin) was installed at each main landing gear yoke to shock strut junction. This was to comply with JAR 25.721(a) and JAR 25.963(d). The purpose of those JAR requirements was to demonstrate adequate airframe strength (especially of the wing in the fuel tank zones) up until the instant where breakage of the fuse pin occurs.

The structural fuse pin was designed to shear if the aircraft touched down in level attitude at a rate of decent of more than 894 to 942 feet per minute – or if - the aircraft touched down in a tail down attitude at a rate of decent of more than 996 to 1029 feet per minute.

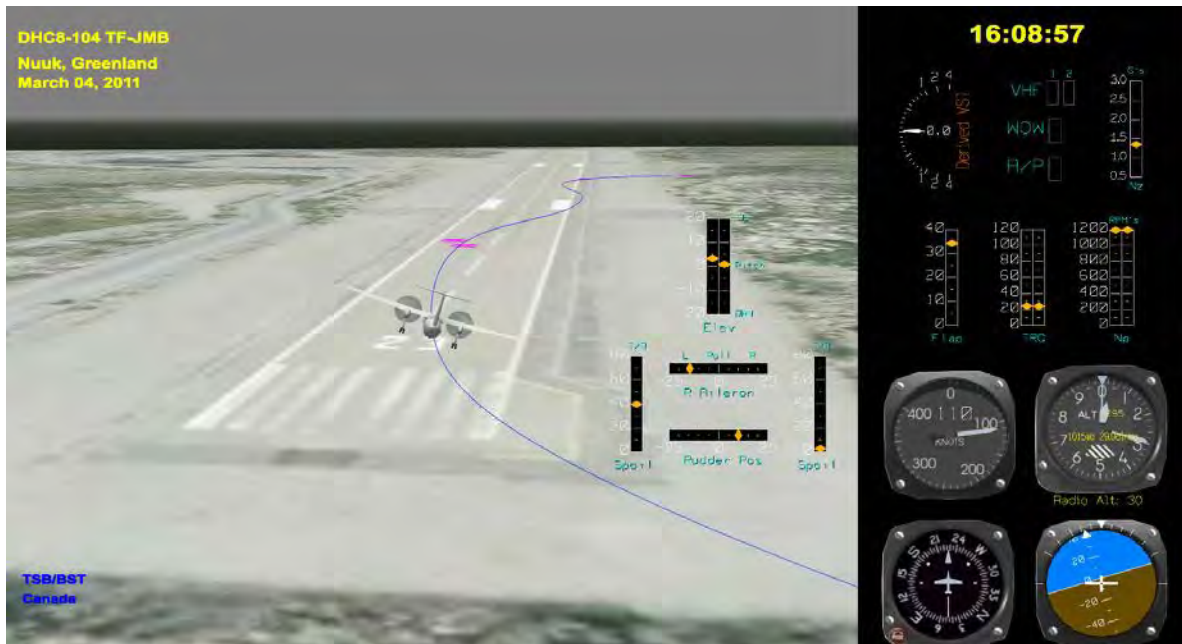
Time 16:08:57 – 30 feet above the runway – banking 18° to the right

The aircraft had passed the runway threshold and descended through 30 feet above runway 23.

The aircraft was banking up to 18.3° to the right but it was drifting to the left. The aircraft overshot the runway centerline to the left. The engine torque was around 24% and was about to be reduced. The RA decreased from 37.8 feet to 24.4 feet or 13.4 feet in one second (804 fpm).

The pitch attitude decreased from the previous -3° to -4° (nose down) to -5.8° (nose down).

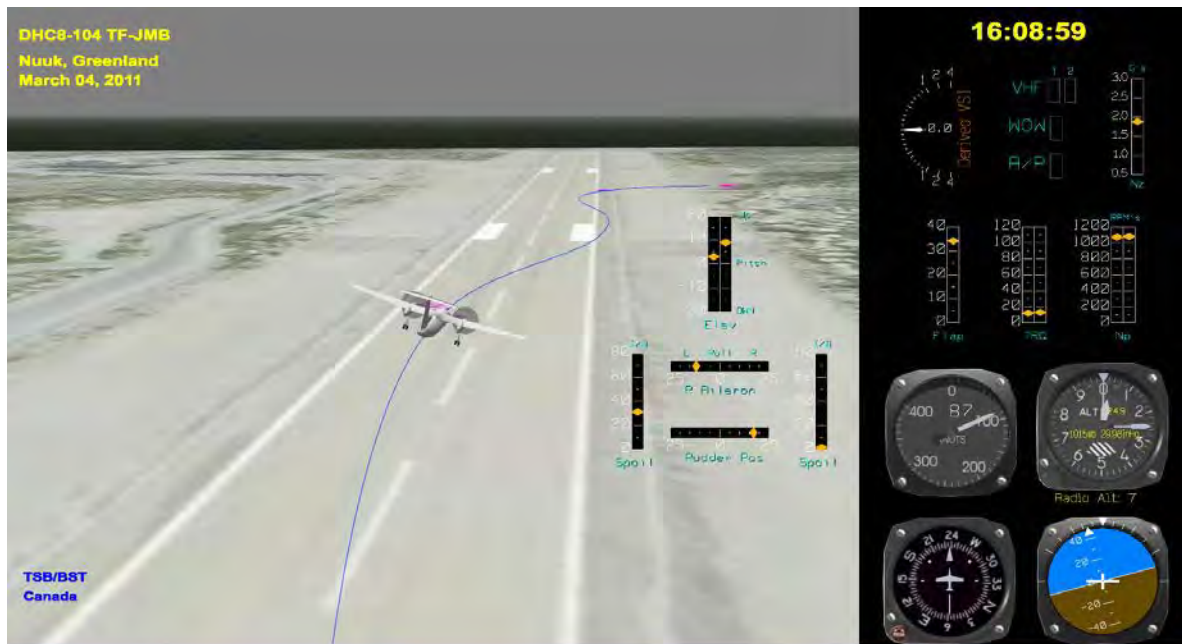
Time 16:08:59 – the flare

The aircraft was in the landing flare. The aircraft was still banking up to 17.9° to the right and the drift to the left had stopped. The aircraft was left of the runway centerline.

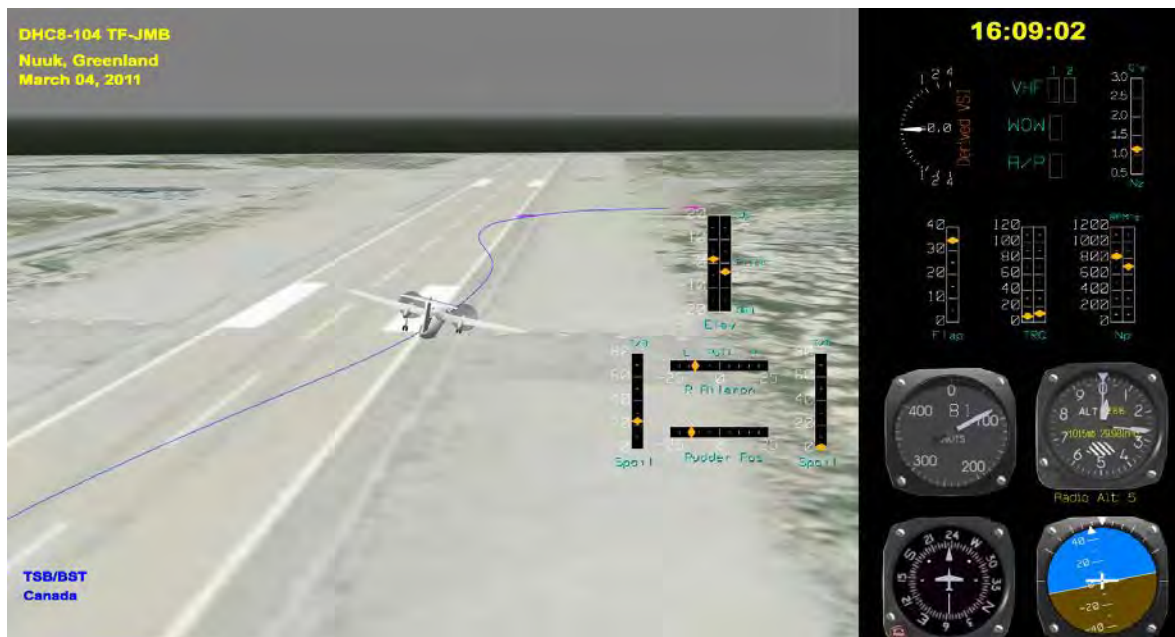
Time 16:09:02 – aircraft sliding down the runway

The aircraft was sliding down runway 23.

Both the engine turbines were running. The propeller on engine #1 was producing forward power (7.9% torque)] and was not used to maintain directional control.

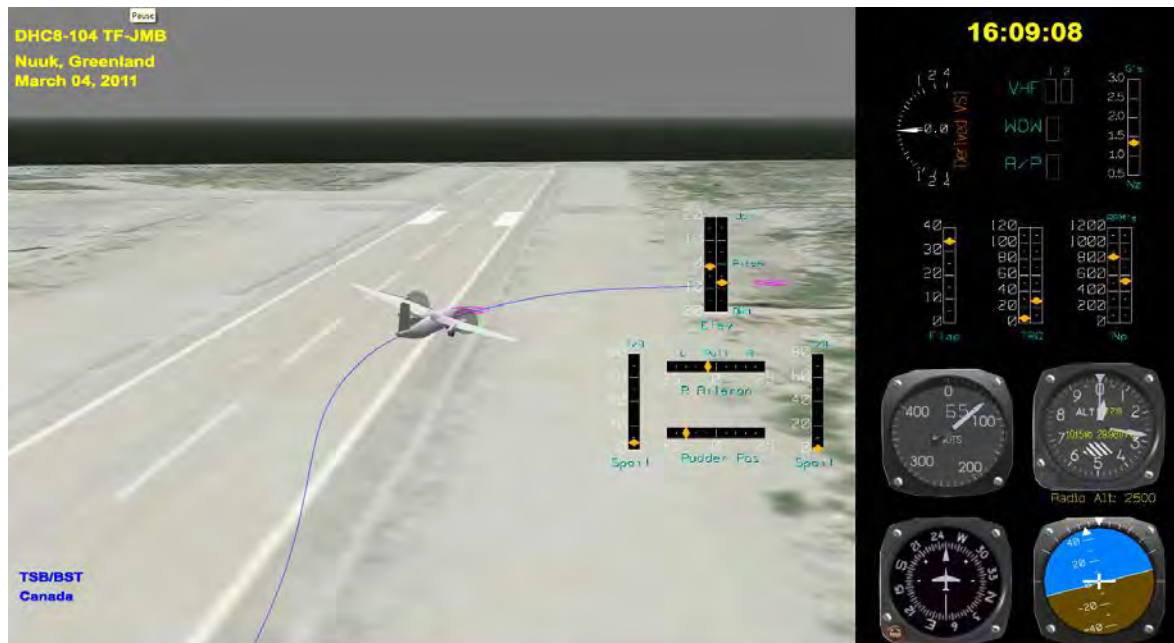
Time 16:09:08 – aircraft sliding off the runway

The aircraft slid off runway 23 and departed the runway to the right.

Both the engine turbines were running. The propeller on engine #1 was still producing forward power (6.3% torque)]. The propeller on engine #2 appeared to produce forward power (28.8% to 26.6% torque) but the outer parts of the propeller blades were gone.

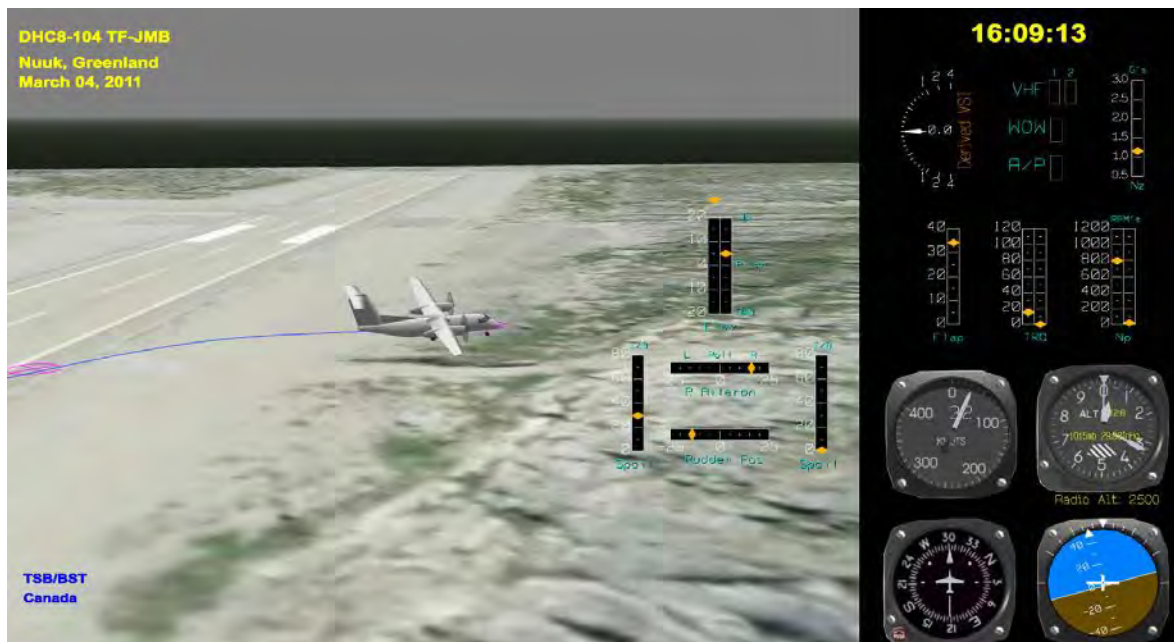
Time 16:09:13 – the aircraft came to rest

The aircraft came to rest to the right of runway 23.

The aircraft pitch angle was +2° nose up and the bank angle was 13° right wing down.
