REPORT ON ACCIDENT

Power loss on take-off after touch-and-go landing

M-03506/AIG-19

Cessna 180H

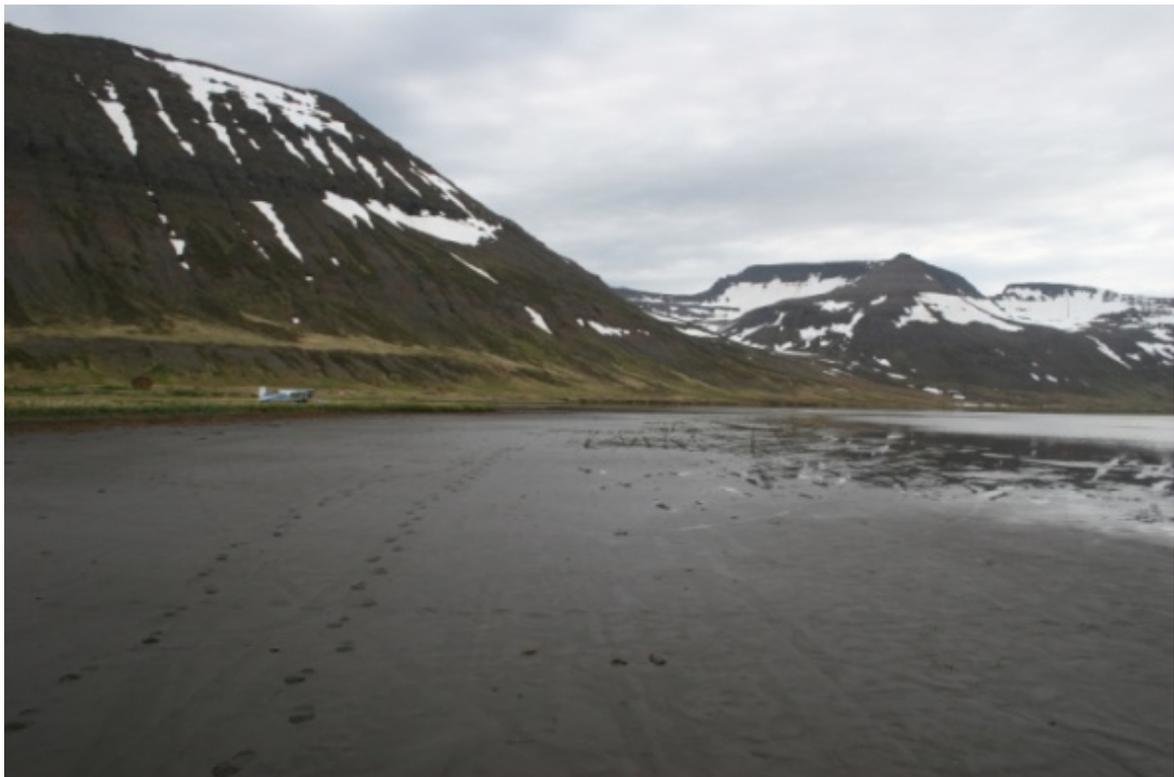
The pilot of N9911V had made a short flight from Fljot to Isafjordur airport and was returning to Fljot. Fljot is in the north-western part of Iceland where aircraft land on a compacted sandy beach, shown in Figure 1. At Fljot there is an amateur weather station. The pilot contacted a person in Fljot via radio to obtain the latest weather information. The reported wind was south-easterly at 10-12 knots.

Figure 1: Landing area in Fljot
