Final report on aircraft accident

Case number: **2015-089-F-026**

Date: **12. November 2015**

Description: **Aircraft collided with the ground during a training flight**

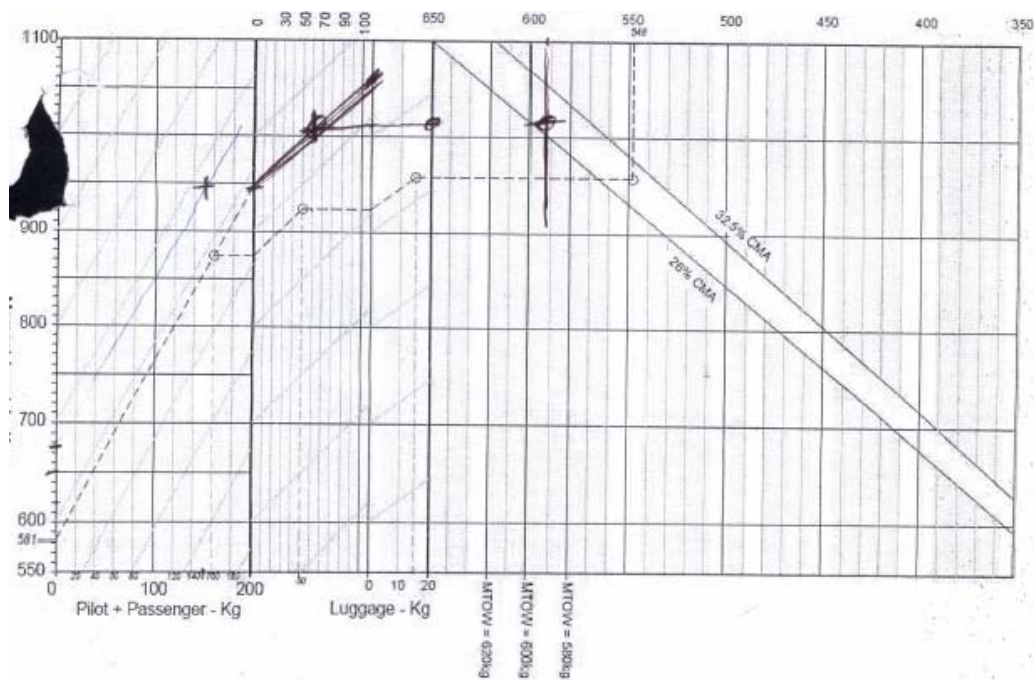
Figure 2: Weight & Balance calculations for the accident flight

According to the Weight and Balance sheet that was prepared for the flight, the aircraft was within the mass and balance envelope's limits.

When analysing the Weight and Balance sheet that was filled out prior to the flight, some discrepancies were found regarding the weight of the Instructor and the Student, as well as regarding the calculation for possible fuel quantity and the weighing report from the manufacturer.

During the investigation, the combined weight of the Instructor and the Student was found to be 169 kg, 19 kg more than the weight listed on the Weight and balance sheet used while preparing for the flight.

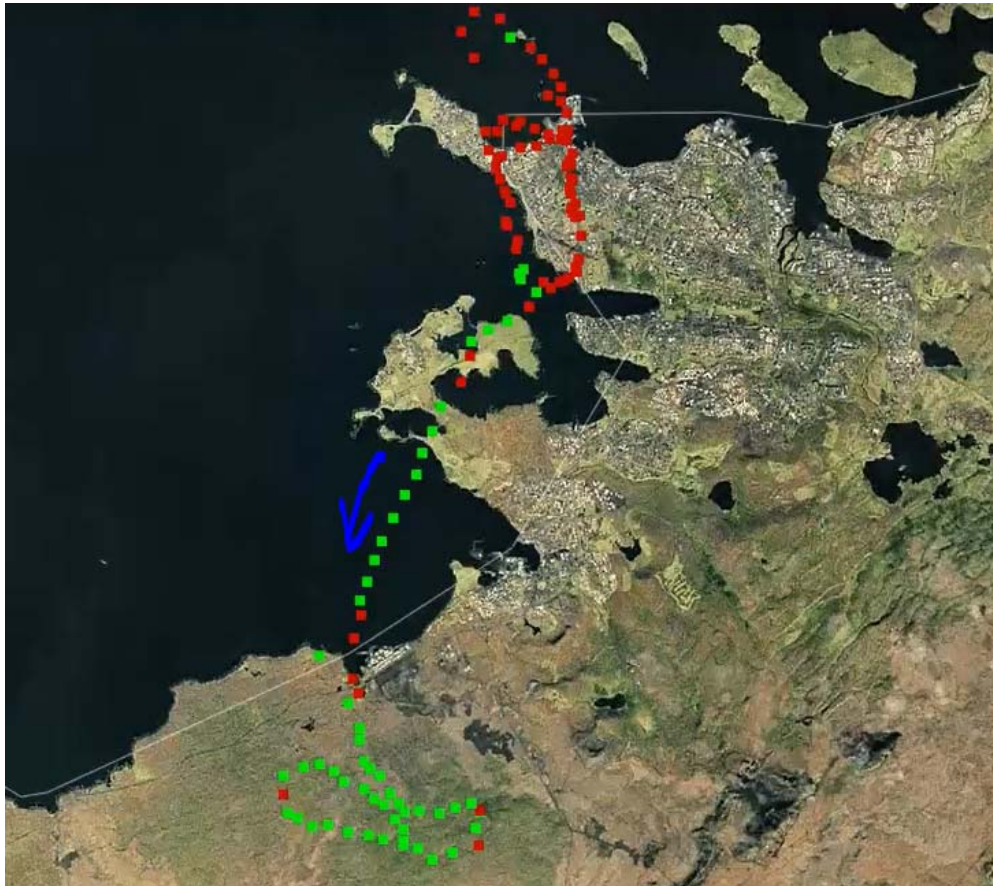
Figure 3: Radar plot of the aircraft - Red dots are primary readout and green are secondary

The aircraft's flight was tracked by ATC radar. The radar plot indicated that the aircraft was flown for three touch and go's at Reykjavik Airport (BIRK) and then the aircraft proceeded to the MIÐSVÆÐI training area. Figure 3 shows the radar plot of the flight at the airport, to and at the training area.

The figure above (Figure 3) is a plot from radar recordings (Mode C) of the aircraft. The figure below (Figure 4) is the last part of the recordings, i.e. after the aircraft entered the training area at MIÐSVÆÐI.

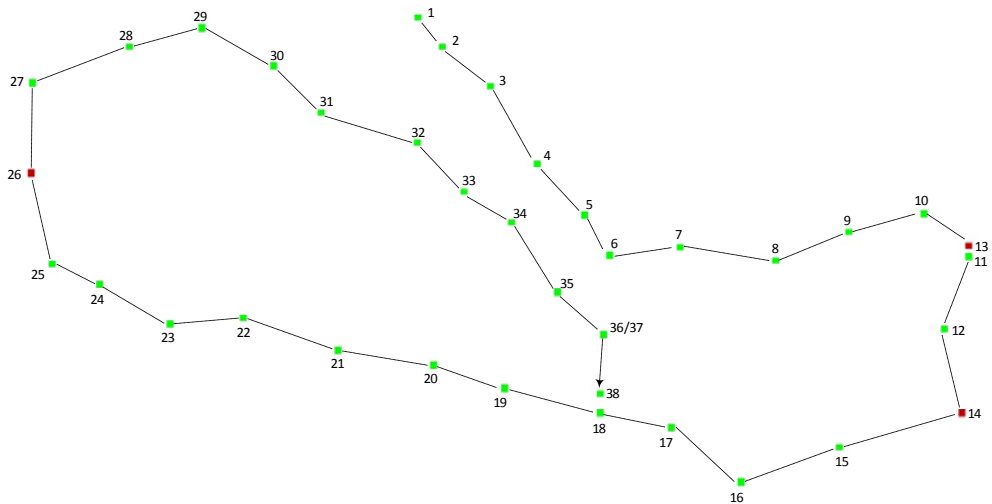
Figure 4: Radar plot from when the aircraft had entered the training area at MIÐSVÆÐI

The aircraft's wreckage was found approximately 260 meters, horizontally from the last recorded radar plot.

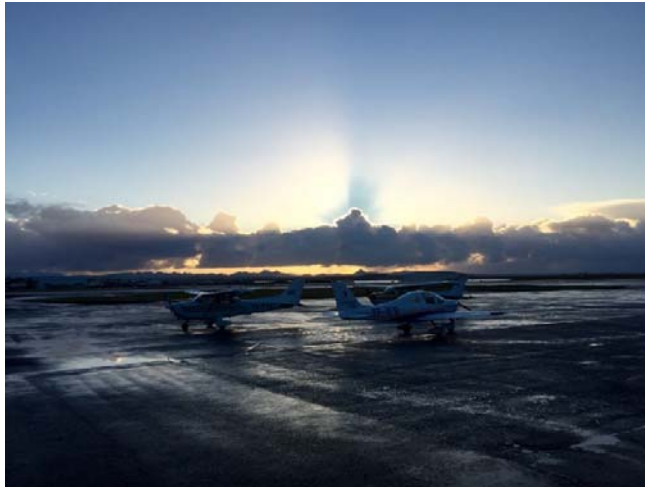
Figure 12: Picture taken towards training area MIÐSVÆÐI

above was taken at BIRK at 15:04 on the day of the accident towards the MIÐSVÆÐI training area.

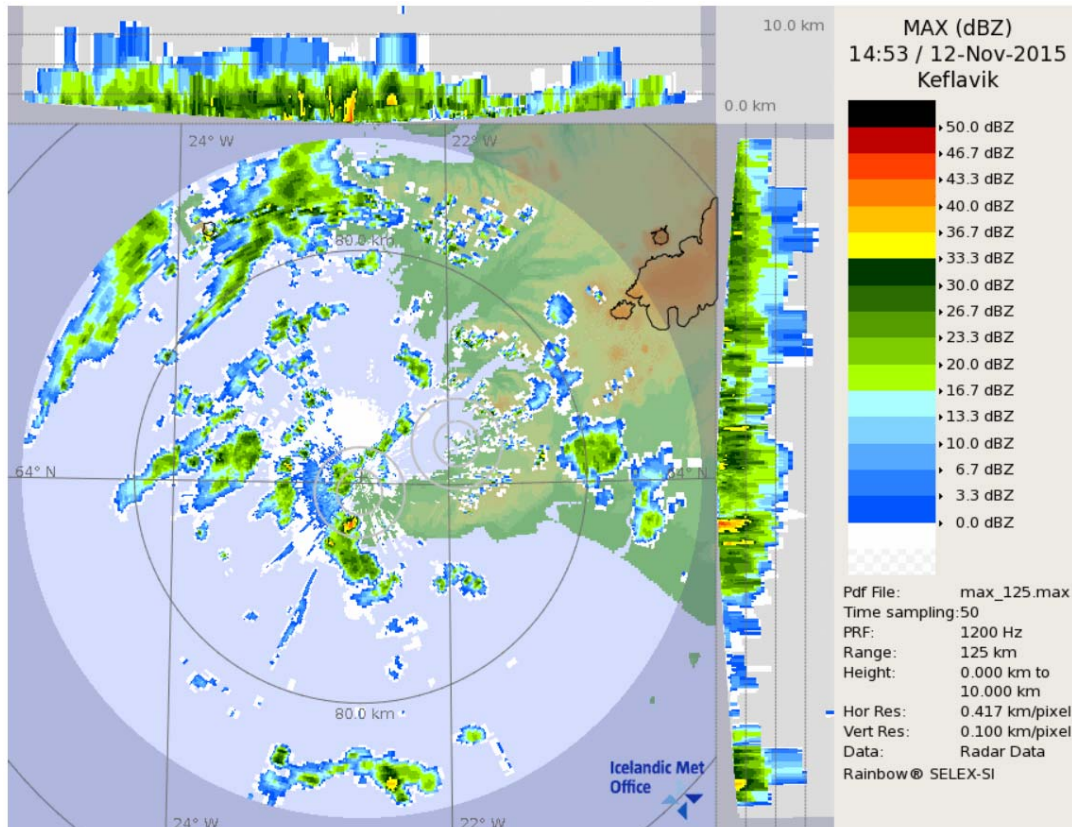
Figure 13: Precipitation in the accident area around the accident time

Figure 13 shows the reflectivity detected by the weather radar at Miðnesheiði, in the vicinity of BIKF. The radar detects particles of size large enough to precipitate. The weather radar did not detect precipitation in the accident area around the accident time. However, the image clearly shows snow showers in the vicinity indicating convective conditions.

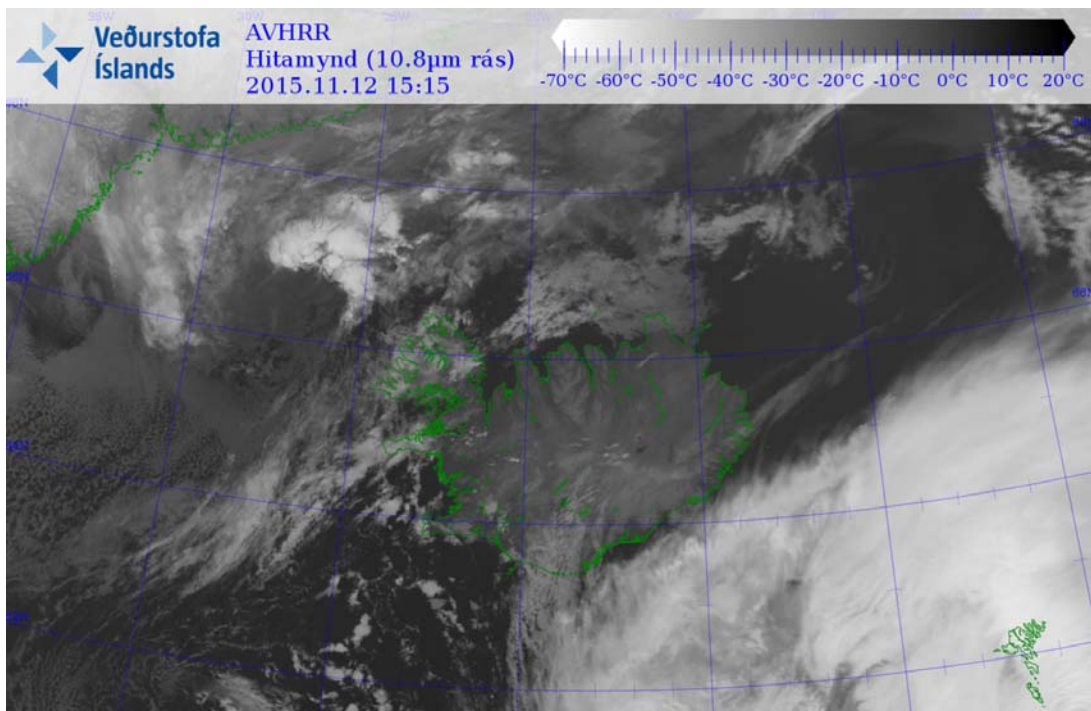
Figure 14: Clouds in the area around the time of the accident

The satellite image in Figure 14 shows no clouds in the region at 15:15, about 32 minutes after the accident.

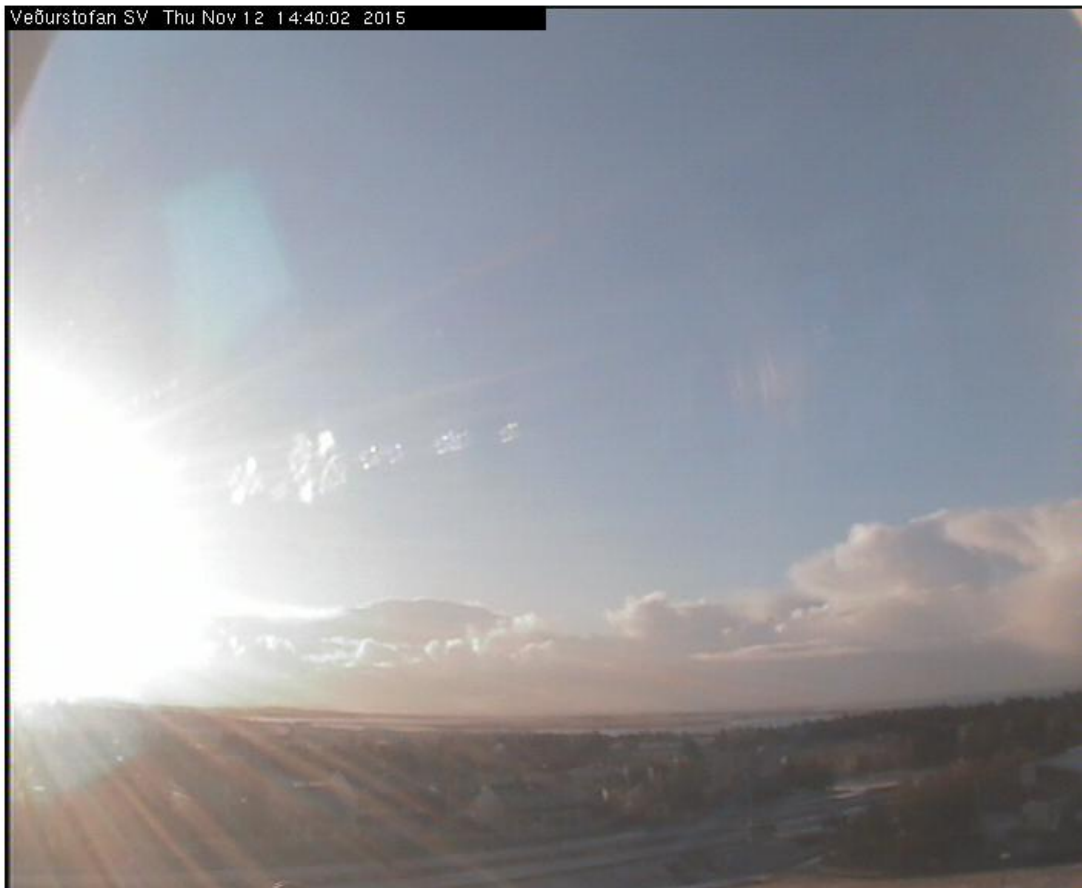
Figure 15: View from the MET Office towards the accident area around the time of the accident

As can be seen in Figure 15, the sun was shining and low in the sky around the time of the accident. The last plotted heading of the aircraft was towards the sun (see Figure 15 and Figure 16), possibly interfering with the pilots' instrument reading.

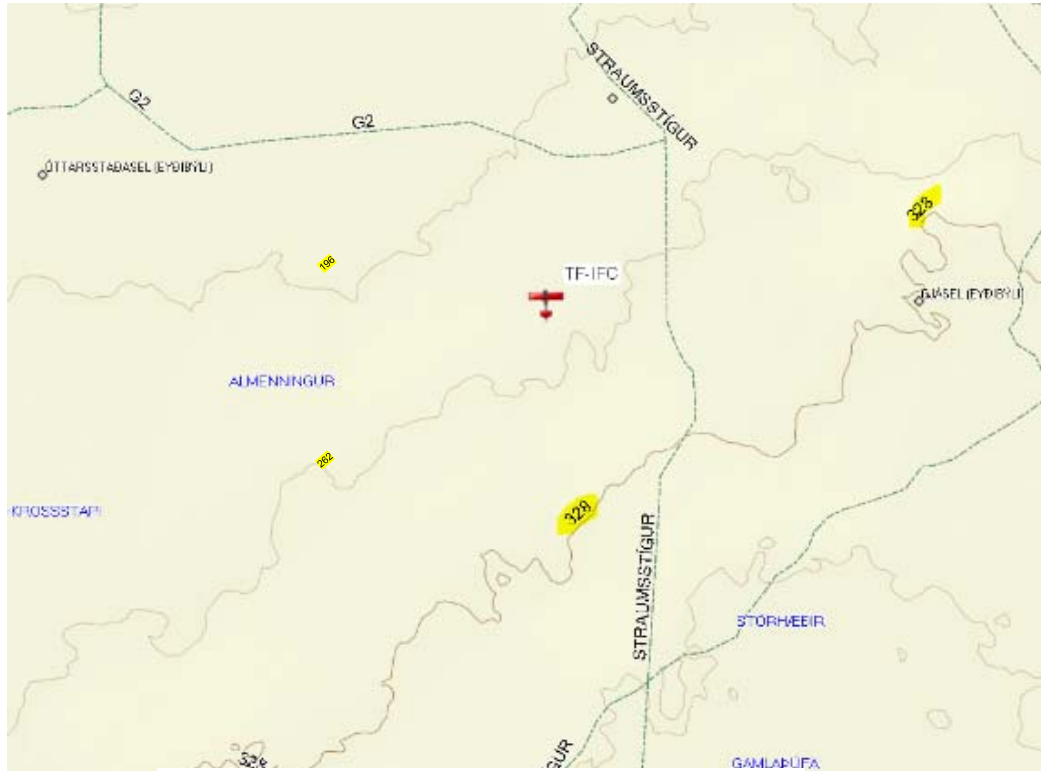
Figure 18: Map of the area around the accident site

The elevation at the accident site, where the training was performed, varies between approximately 200-330 feet. The elevation at the area where the aircraft was found is approximately 250 feet.

The last recorded radar signal, showed the aircraft at approx. 2450' ASL or 2200' AGL.

Within the area MIÐSVÆÐI, there are hills, knolls and mountains that vary in heights from 600 – 1300 feet.

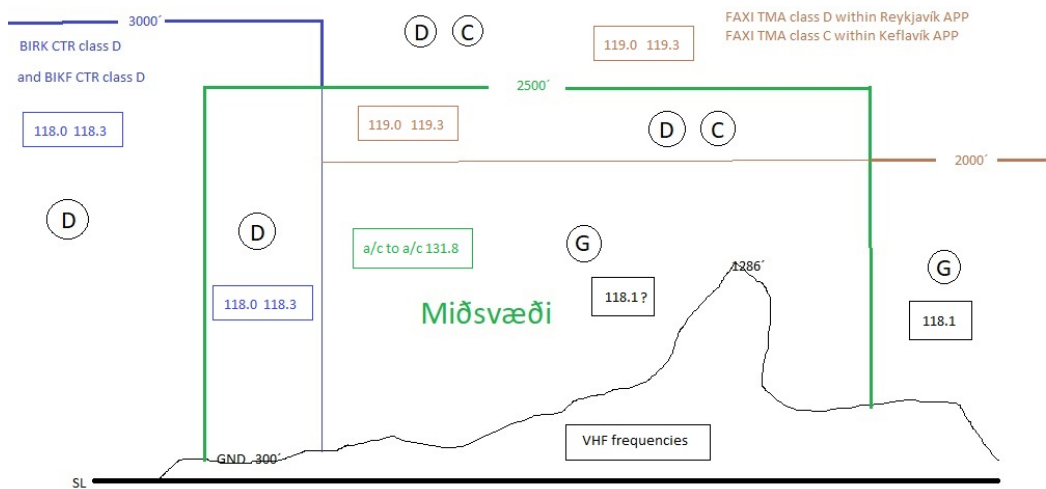
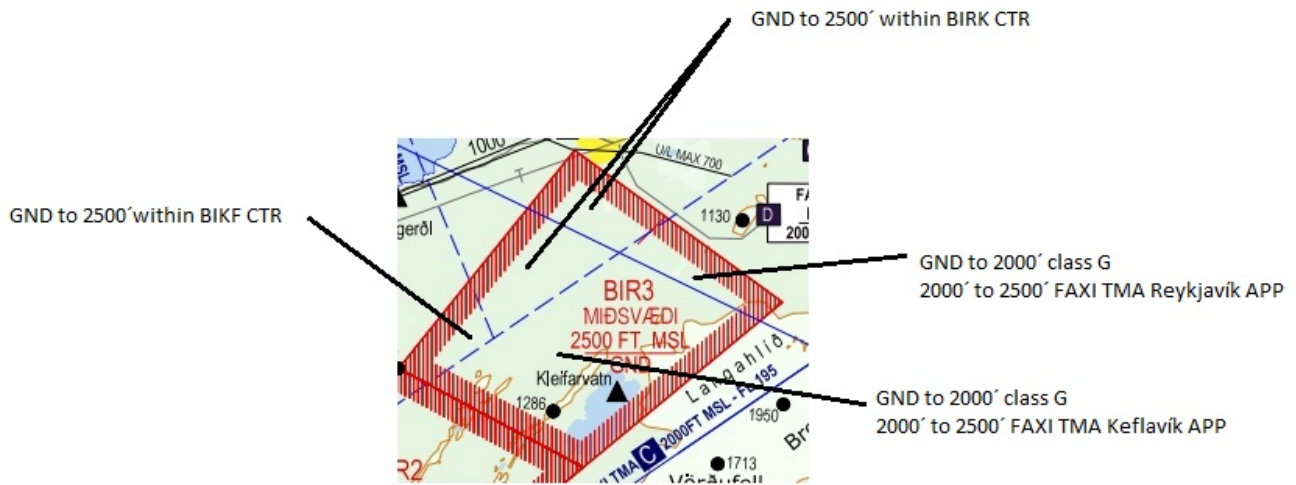
Figure 19: MIÐSVÆÐI

There are three different airspace classes¹⁷ at MIÐSVÆÐI, Class C, D and G depending on the location from time to time.

The investigation revealed that the area is more complicated than other training areas and in case of higher altitude needed (above 2500' MSL) the pilots need to contact either one of two approach control units, i.e. BIRK Approach and BIKF Approach. Due to this, some instructors use other training areas for higher altitude

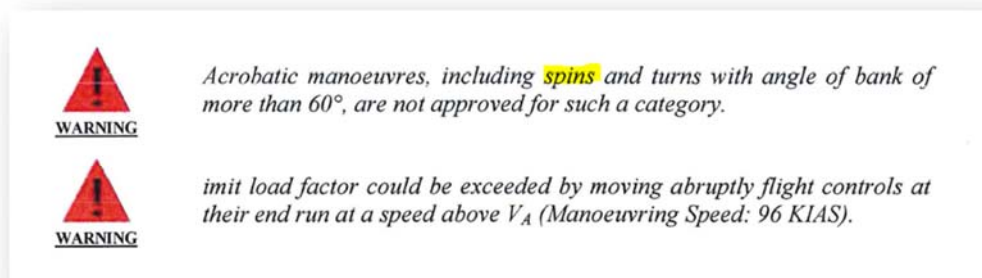
Figure 21: Warning note in AFM regarding intentional spin

Intentional spins are not approved within normal category and a special warning note is in the AFM²¹.

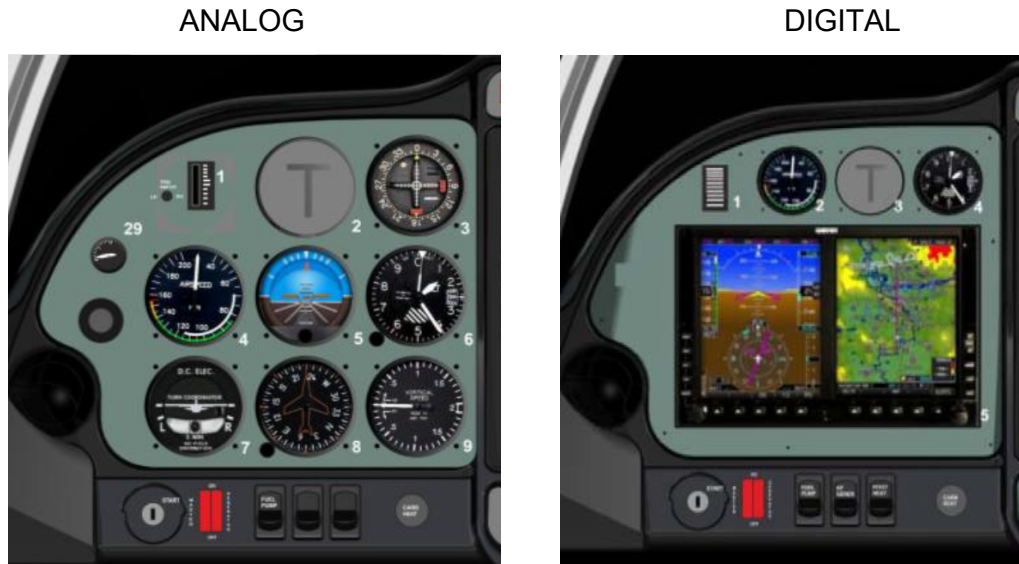
Figure 31: The difference between analog and digital panels

Figure 31 demonstrates the difference between the analog and the digital panels of the Tecnam P2002JF. At the digital configuration there are also some analog instruments as a standby instruments.

Numerous inconsistencies were found between the airspeed limitation given in the aircraft's handbook and those marked on the airspeed indicator of the accident aircraft.

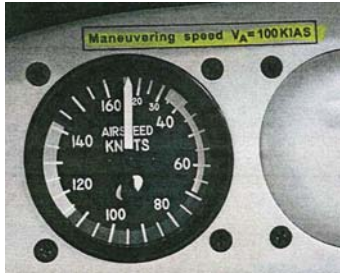
<p>Tecnam P2002-JF Flight Manual</p>	<p>Aircraft</p>
<p style="border: 1px solid black; padding: 5px; text-align: center;">MANEUVERING SPEED $V_A = 96$ KIAS</p>	<p>100 KIAS in aircraft</p>

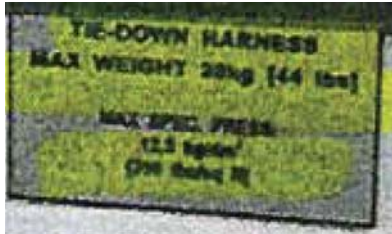
<p style="border: 1px solid black; padding: 5px;">THIS AIRPLANE IS CLASSIFIED AS A VERY LIGHT AIRPLANE APPROVED FOR DAY VFR ONLY, IN NON-ICING CONDITIONS. ALL AEROBATIC MANEUVERS INCLUDING INTENTIONAL SPIN ARE PROHIBITED. SEE FLIGHT MANUAL FOR OTHER LIMITATIONS.</p>	<p>Missing in Aircraft</p>
<p style="border: 1px solid black; padding: 10px; text-align: center;">FASTEN TIE-DOWN NET MAXIMUM WEIGHT <i>20 KG</i> MAX. PRESS <i>12.5 kg/dm²</i></p>	<p>Tie-Down Harness in aircraft</p>
