### Final report on aircraft serious incident

Case no.: **19-159F044**

Location: **RWY 01 at Keflavik Airport**

Description: **Declared emergency due to low fuel and landed on a closed runway**

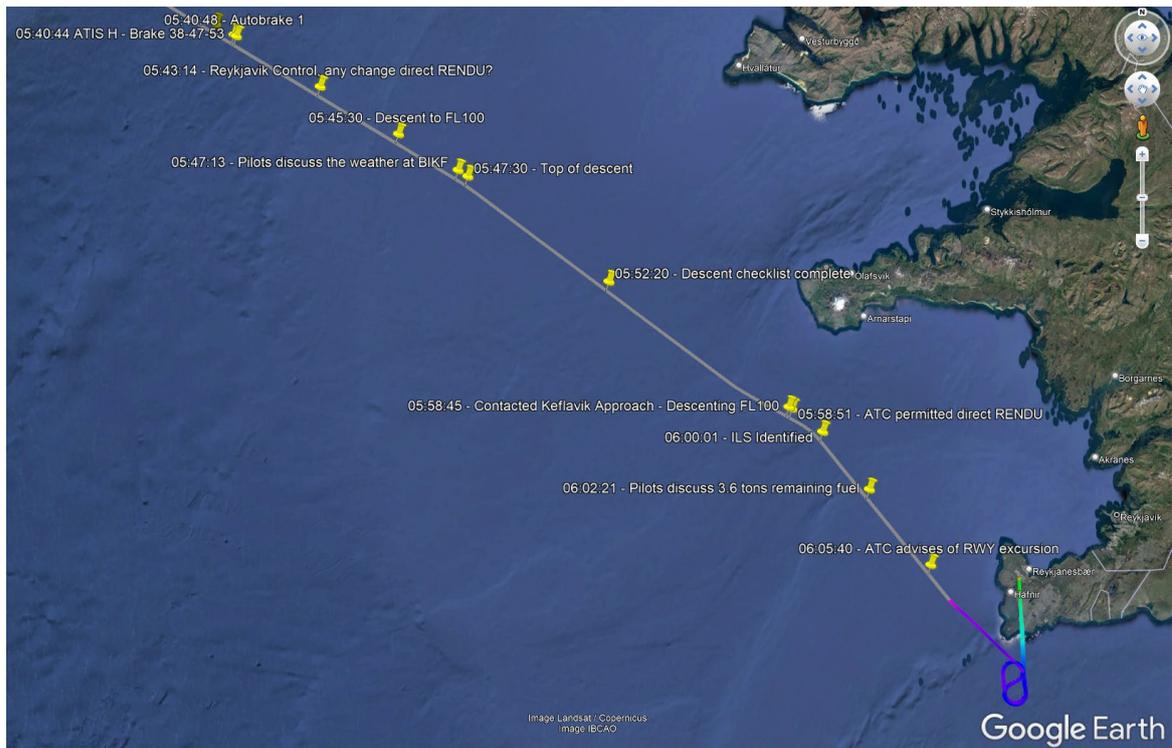
At 05:58, Reykjavik Control contacted the flight crew and instructed them to contact Keflavik Approach at 119.3 MHz and that Keflavik Approach would clear them direct to RENDU as soon as possible. Subsequently, the flight crew contacted Keflavik Approach and reported that they were descending through FL100. Keflavik Approach replied with a

**Figure 2: Flight path of flight ICEAIR 680 between 05:40 and 06:05**

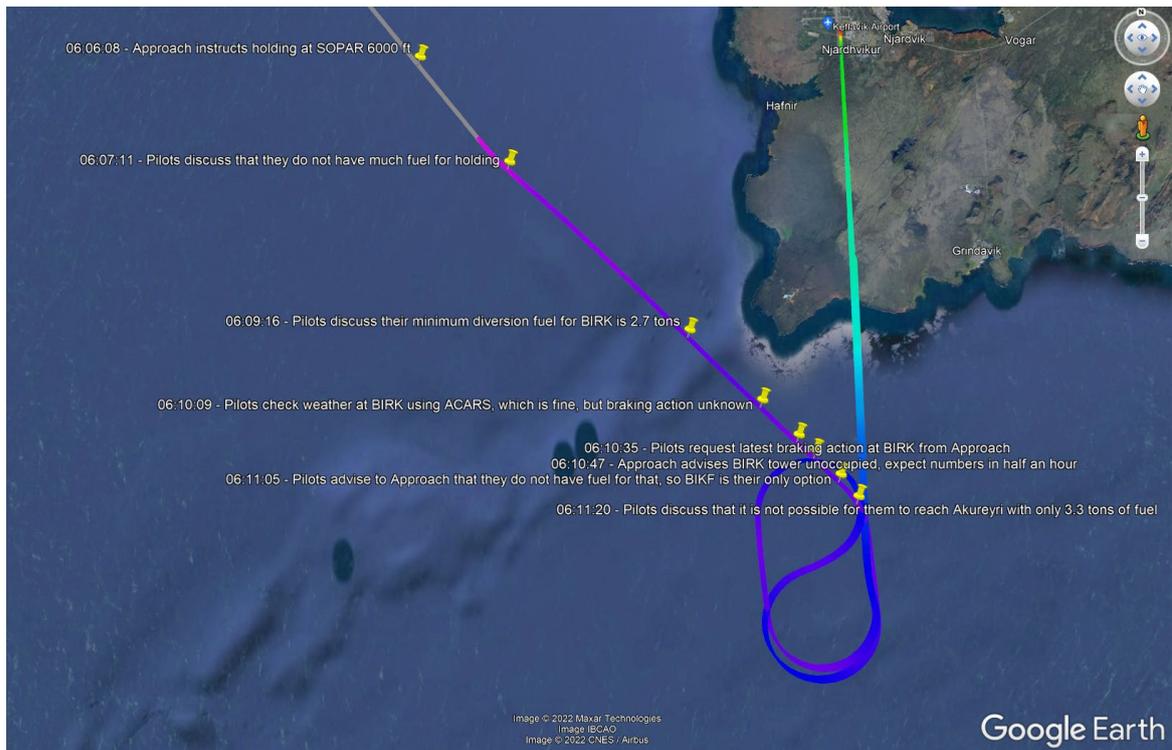
*"Ok, we do not have fuel for that, so Keflavik is the only option."*

**Figure 3: Flight path of flight ICEAIR 680 between 06:06 and 06:11**

At 06:11:20, the Commander stated to the First Officer that they would not be able to go to Akureyri Airport with their remaining fuel of 3.3 tons. The First Officer concurred.

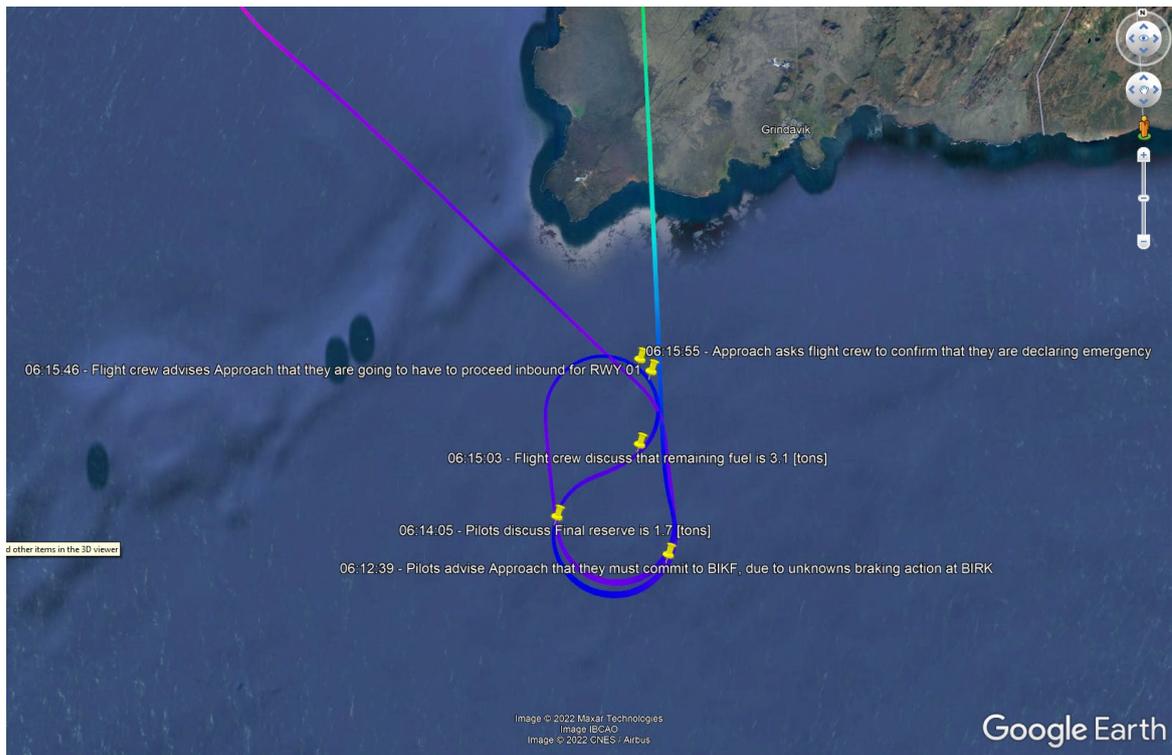
**Figure 4: Flight path of flight ICEAIR 680 between 06:12 and 06:16**

The flight crew discussed that they had no option, as they did not have the braking action at Reykjavik and that their remaining fuel was almost down to 3.0 tons.

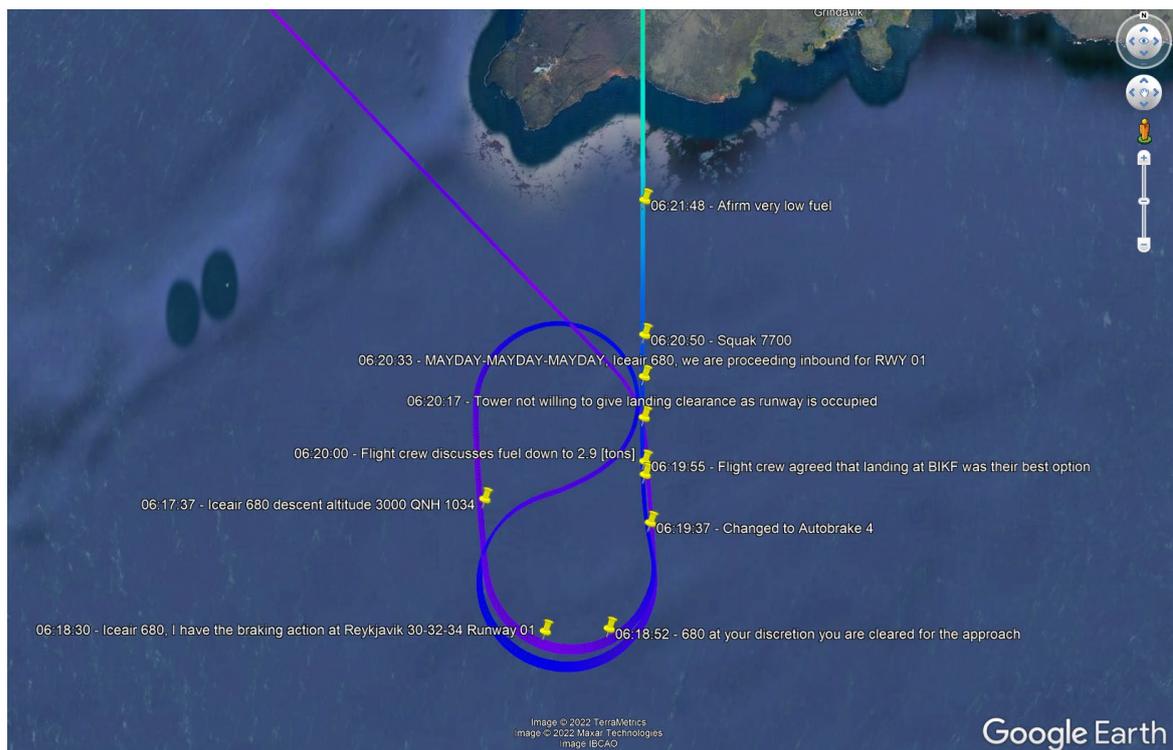
**Figure 5: Flight path of flight ICEAIR 680 between 06:17 and 06:21**

The flight crew squawked 7700 and continued the approach.

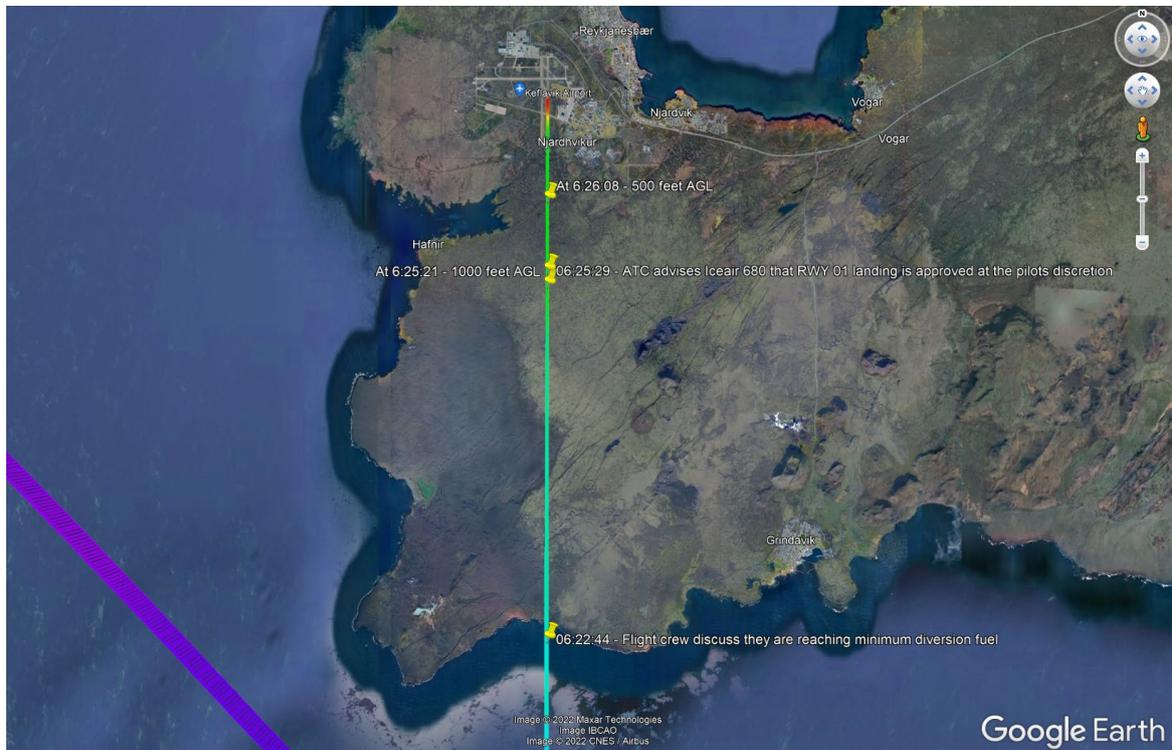
**Figure 6: Flight path of flight ICEAIR 680 between 06:21 and 06:26**

At 06:22:44, the flight crew discussed that they had reached minimum diversion fuel.

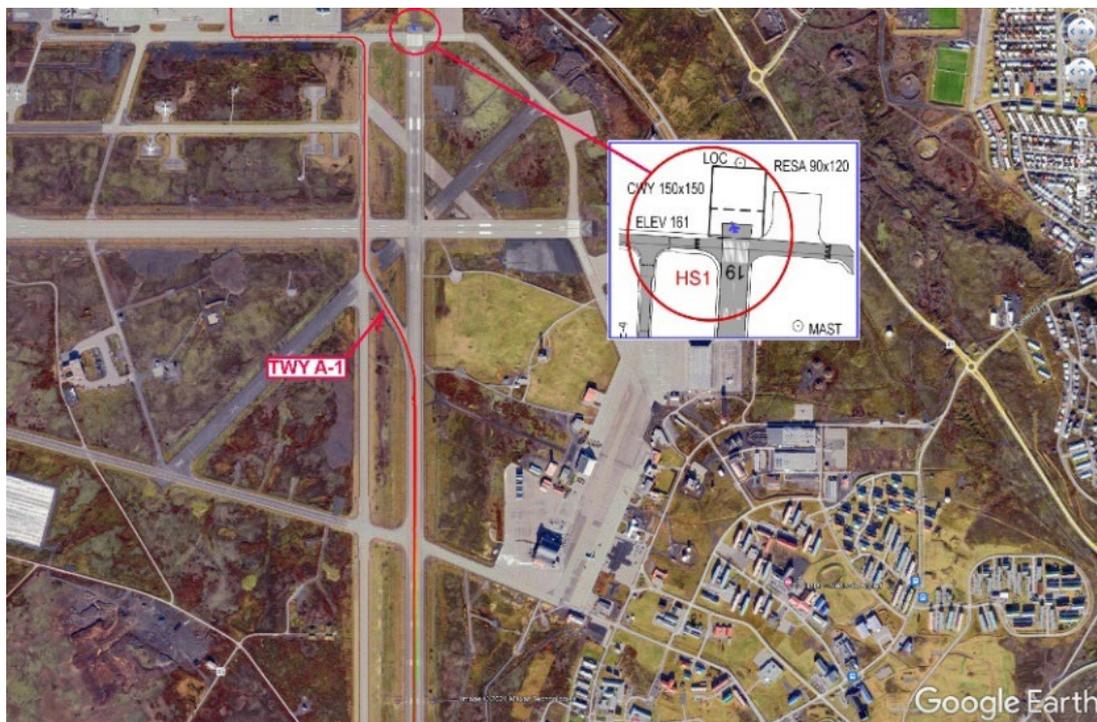
At 06:26:43, flight ICEAIR 680 landed on RWY 01 at Keflavik Airport and Autobrake 4 was employed.

When flight ICEAIR 680 landed, its remaining fuel was 2.6 tons.

**Figure 7: Flight ICEAIR 680 vacated RWY 01 at TWY A-1**

During the landing roll, the flight crew turned off the landing lights in order not to disturb the team working on the runway end, on the aircraft that had incurred runway excursion. Flight ICEAIR 680 vacated RWY 01 at taxiway A-1.

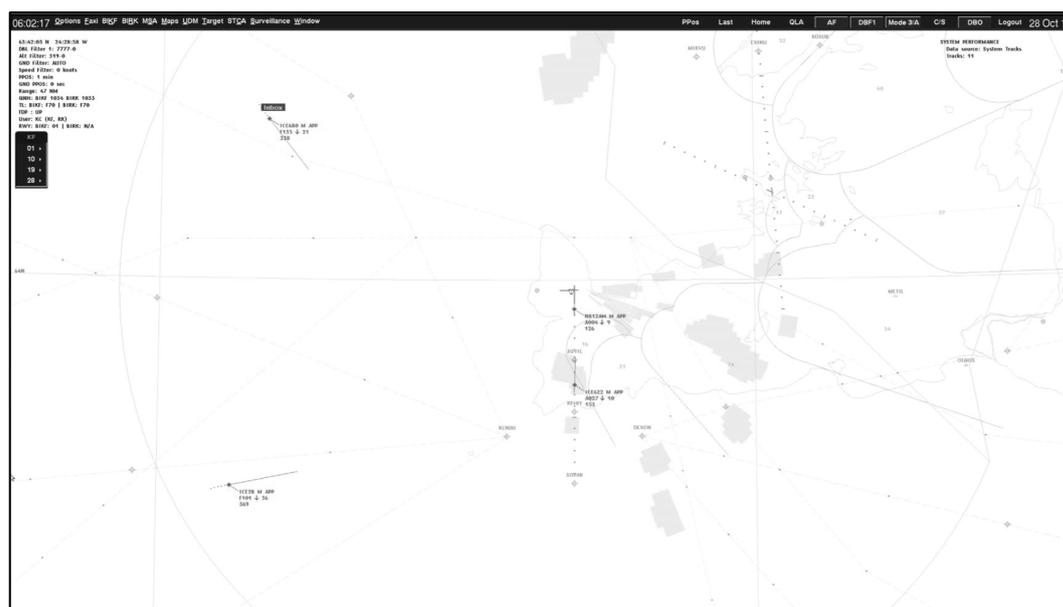
Figure 15: Picture of the radar screen in FAXI at 06:02:17

The flight crew of flight ICEAIR 680 then discussed amongst themselves that the remaining fuel was 3.6 tons.
