Report on aircraft serious incident

Case no: **M-01913/AIG-14**

Date: **20. October 2013**

Description: **Loss of engine power**

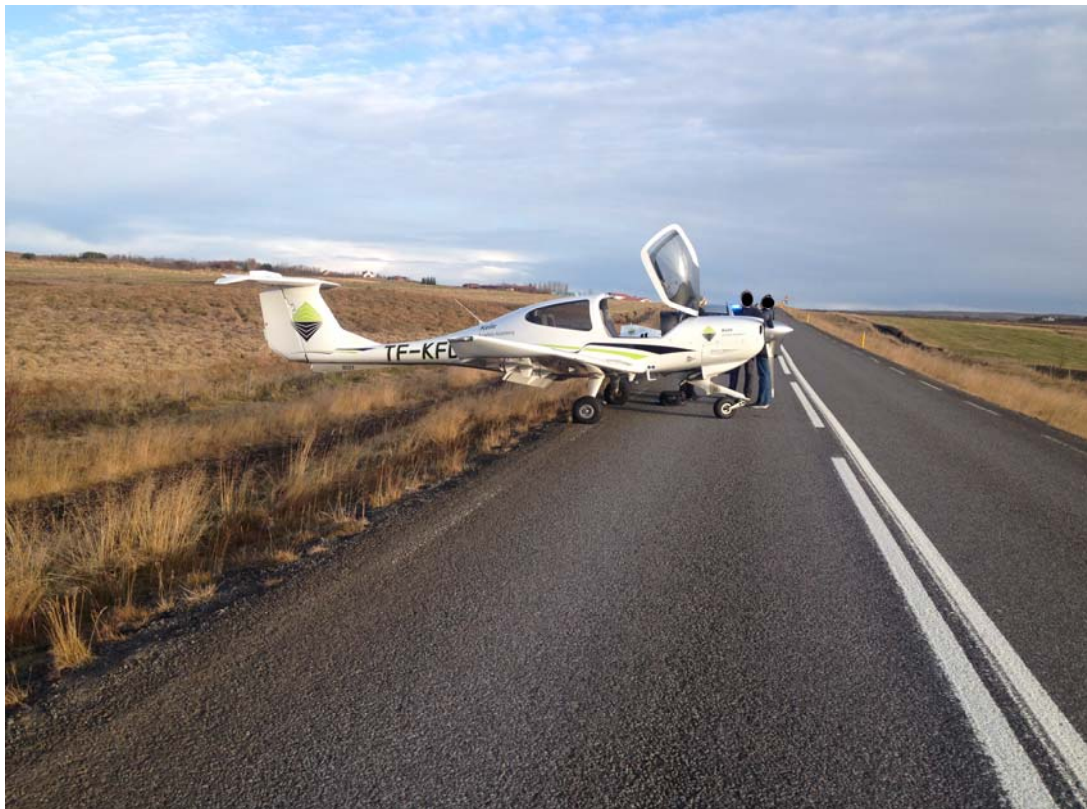
The pilot and the passenger had no problem exiting the airplane. As they had landed on a road, they decided to move the airplane so only one of the road's lanes would be blocked. See Figure 3.

Figure 3: The location of the incident airplane upon arrival of ITSB investigator
