# AIRCRAFT ACCIDENT FINAL REPORT

Landed short of runway

M-05608/AIG-16 N558RS Piper PA 46 (Malibu Mirage) Egilsstaðir Airport Iceland September 11, 2008

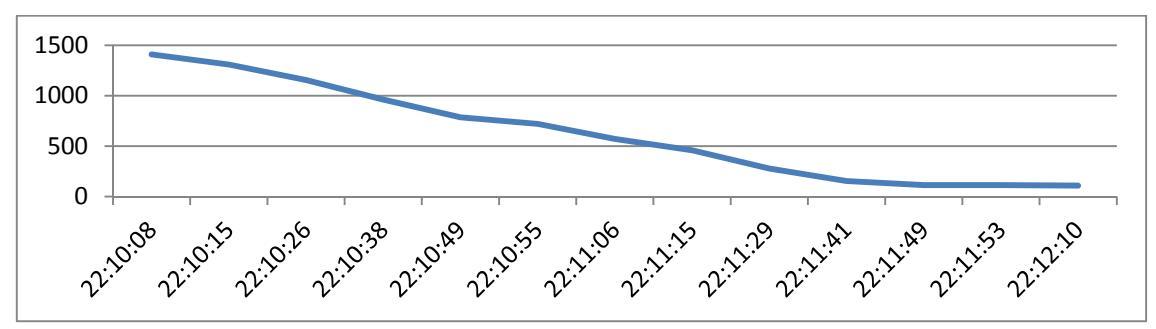
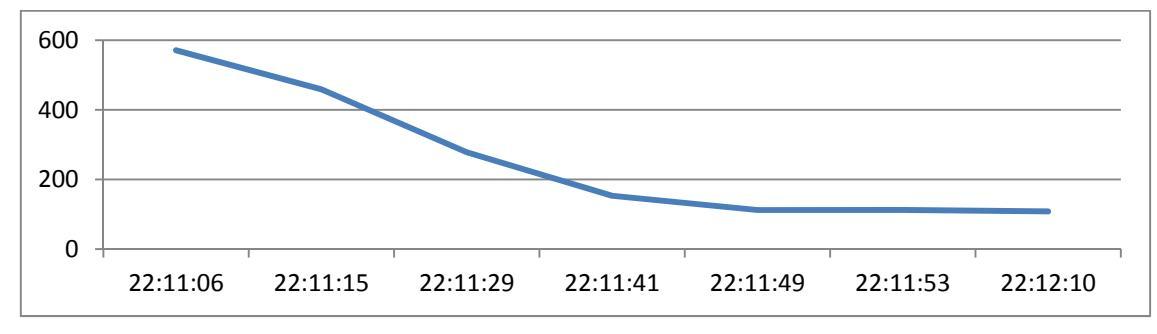
Profile from 1.400 feet to landing

The aircraft's glide path was above the instrument approach chart's (LLZ/GP) until the aircraft entered a fog patch approximately 2 NM from the displaced threshold. When the aircraft entered the fog, the rate of descent increased resulting in the aircraft hitting the ground short of the runway. Entering a fog layer can create the illusion of a pitch-up attitude that may cause a pilot to respond with a nose-down correction, which steepens the approach path.<sup>7</sup>
