Report on aircraft accident

Case no: **M-01313/AIG-09**

Date: **21. July 2013**

Description: **Runway excursion during flight testing**

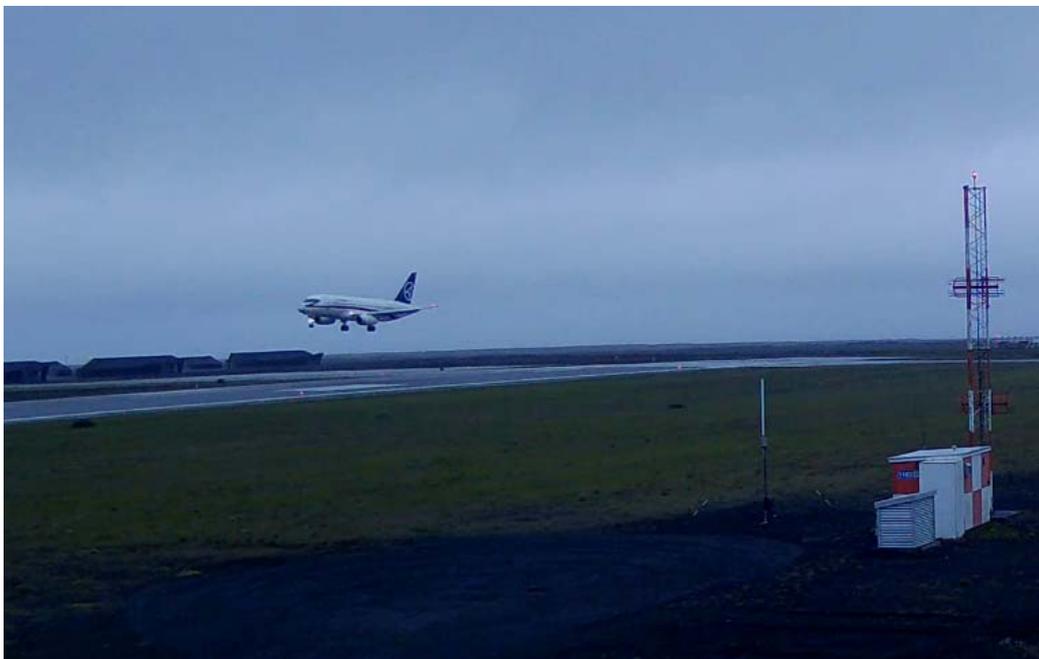
During the final approach to RWY 11 at 05:22:22, the landing gear was selected to down position. See Figure 1. The approach was normal.

Figure 1: Landing gear down on final approach to RWY 11

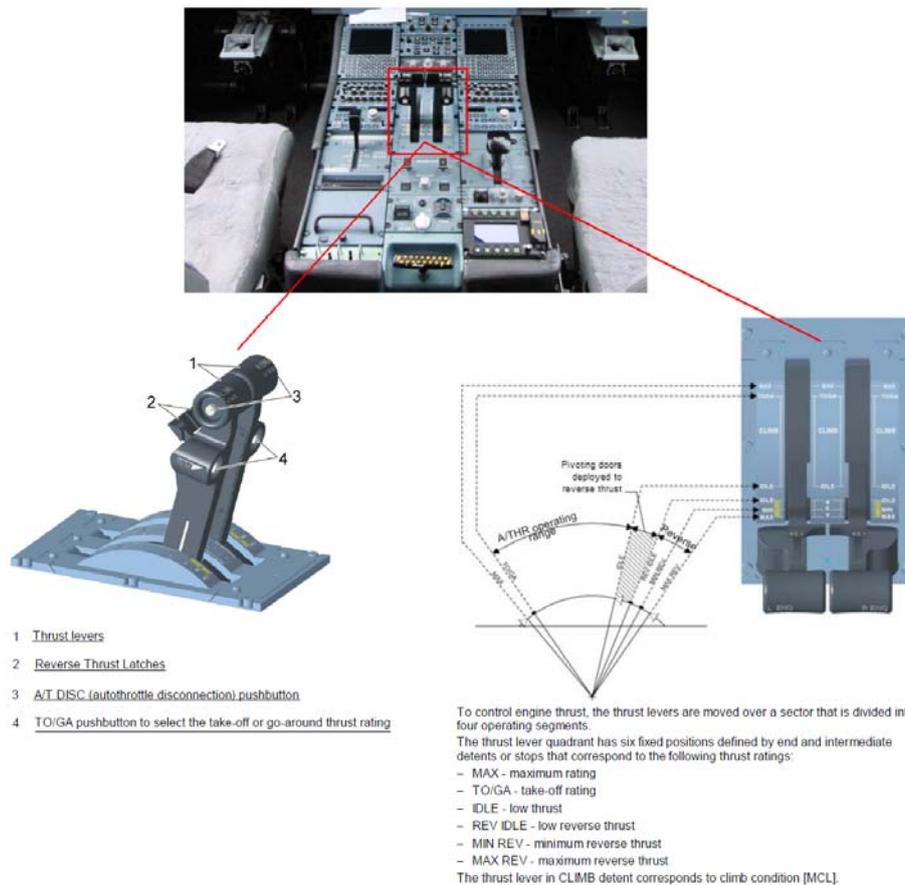
The pilot flying then noticed at the primary flight display that the go-around mode had not engaged when he selected the TOGA switch. Details on this system can be found in Figure 4. The pilot flying also noticed that the FD was not available and that the A/T was switched off.

Figure 4: Explanation of the TQL and the TOGA

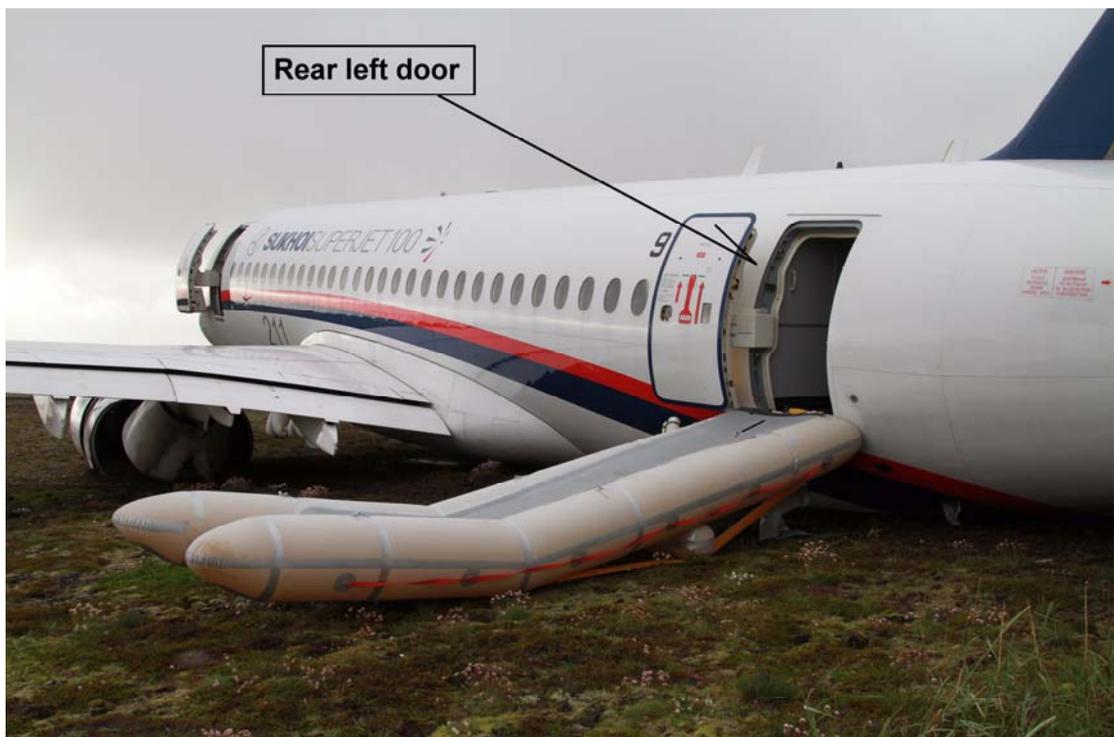
After the airplane had come to a stop, the pilot in command, who was also the pilot flying, ordered an emergency evacuation. The forward left door was opened by the cockpit crew, but the emergency escape slide did not deploy. See Figure 6. The crew member operating the test equipment in the cabin opened the rear left door and its slide deployed. The cockpit crew then opened the forward right door. The slide deployed, but due to the crosswind it blew underneath the belly of the airplane and was unusable. The whole crew evacuated the airplane via the rear left door. See Figure 7.

Figure 7: Crew evacuated the airplane via the rear left door

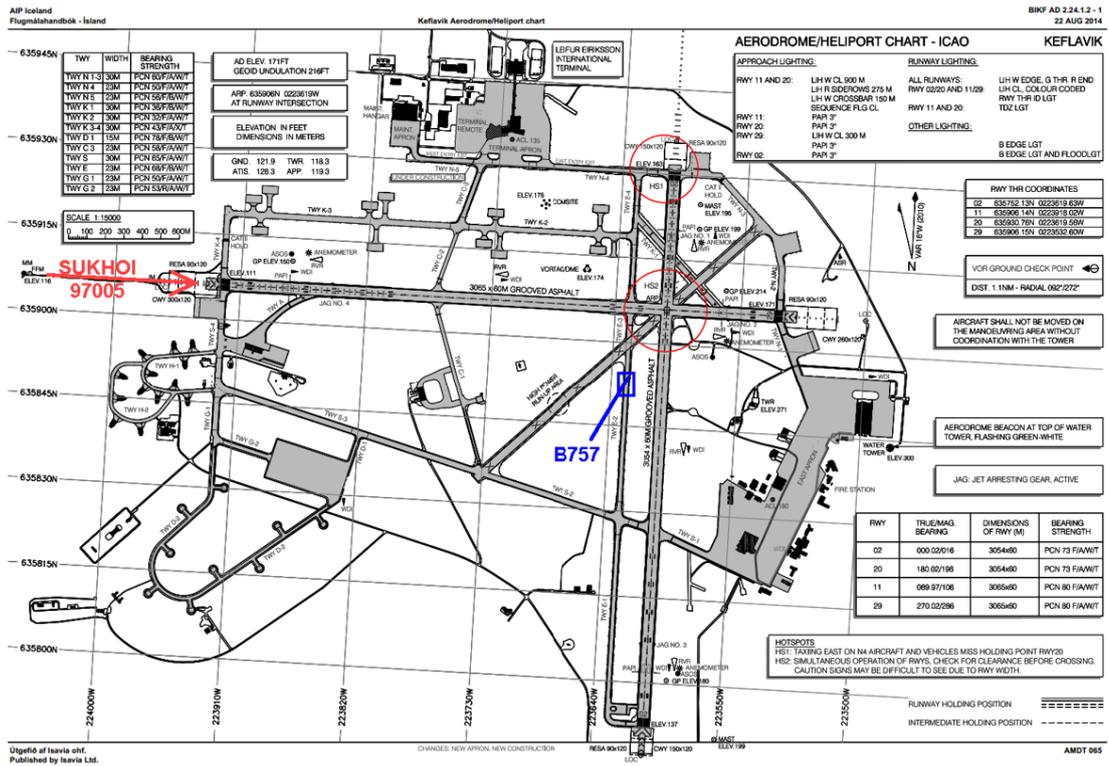
When the Sukhoi 97005 airplane skidded down RWY 11, a B757 airplane that had landed previously on RWY 20 was holding short of RWY 11 on TWY E-2 (Echo), near the end where TWY E-3 begins. See Figure 9 for details.

Figure 9: Chart showing Keflavik Airport (Isavia)

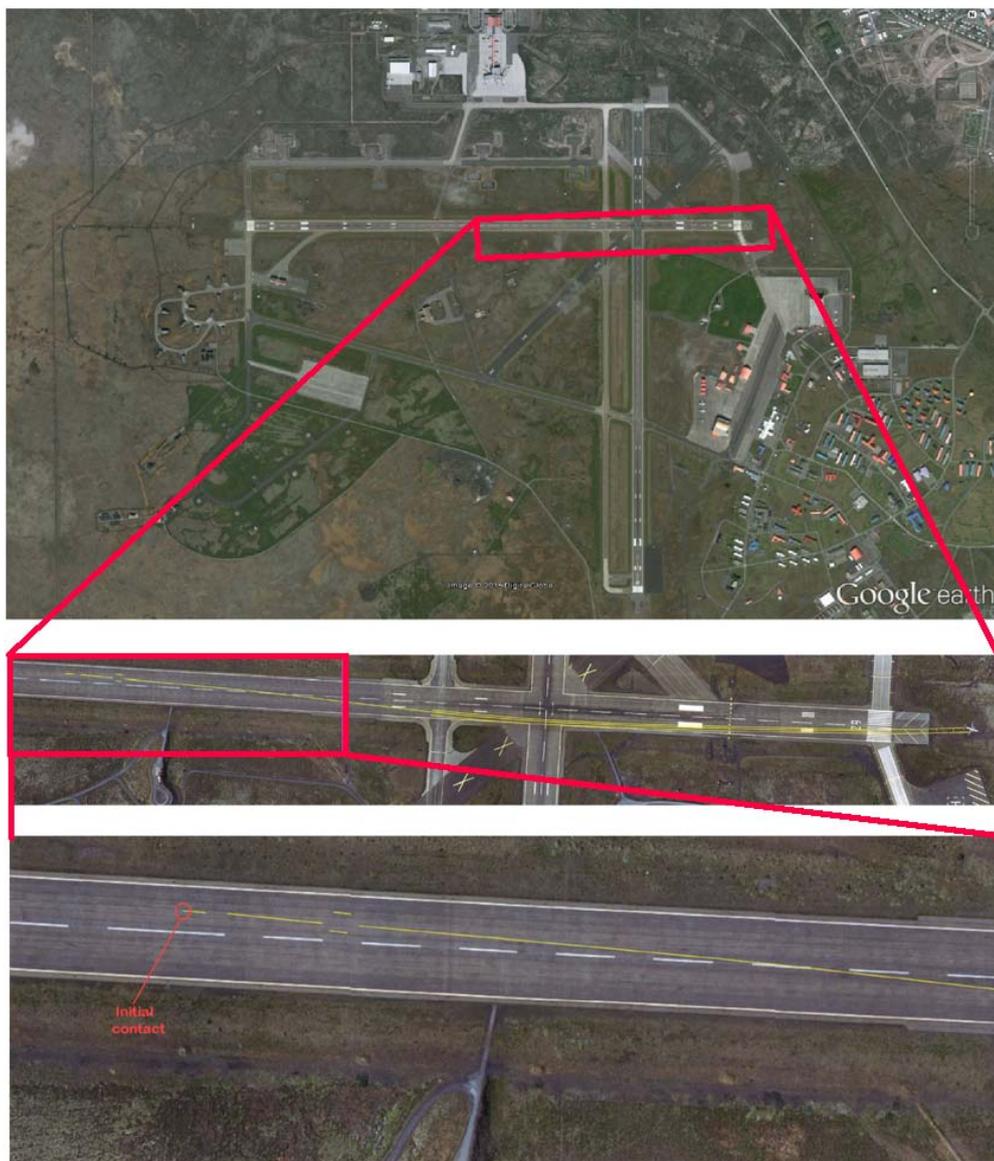
The airplane landed on RWY 11 on its lower aft fuselage belly left of the center line, about 360 meters beyond TWY C1/C2. The airplane then skidded 1.6 km down the runway and came to rest after having passed 163 meters beyond the threshold of RWY 29.

Detailed measuring and recording of the skid marks was performed by local police investigators³⁶ with the assistance of the Icelandic Coast Guard. Part of Figure 10 and Figure 11 to Figure 13 are from the police report.

Figure 10: Keflavik Airport (BIKF) and RWY 11 (view in red enlarged twice)

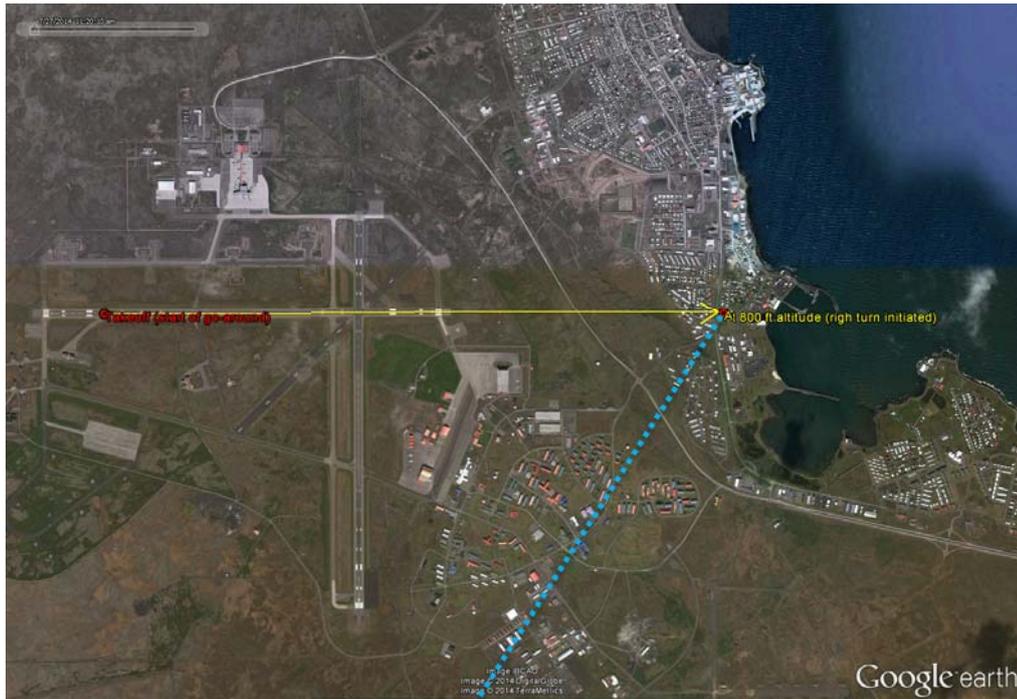
The investigation revealed that the flight testing of an airplane on RWY 11 at Keflavik Airport would take the airplane over populated residential area in Innri-Njarðvík, Reykjanesbær, at minimum clearance altitude with one engine inoperative, during the take-off section of the testing. See Figure 17 and Figure 18 for details.

Figure 17: Calculated track from takeoff to 800 feet altitude under test condition

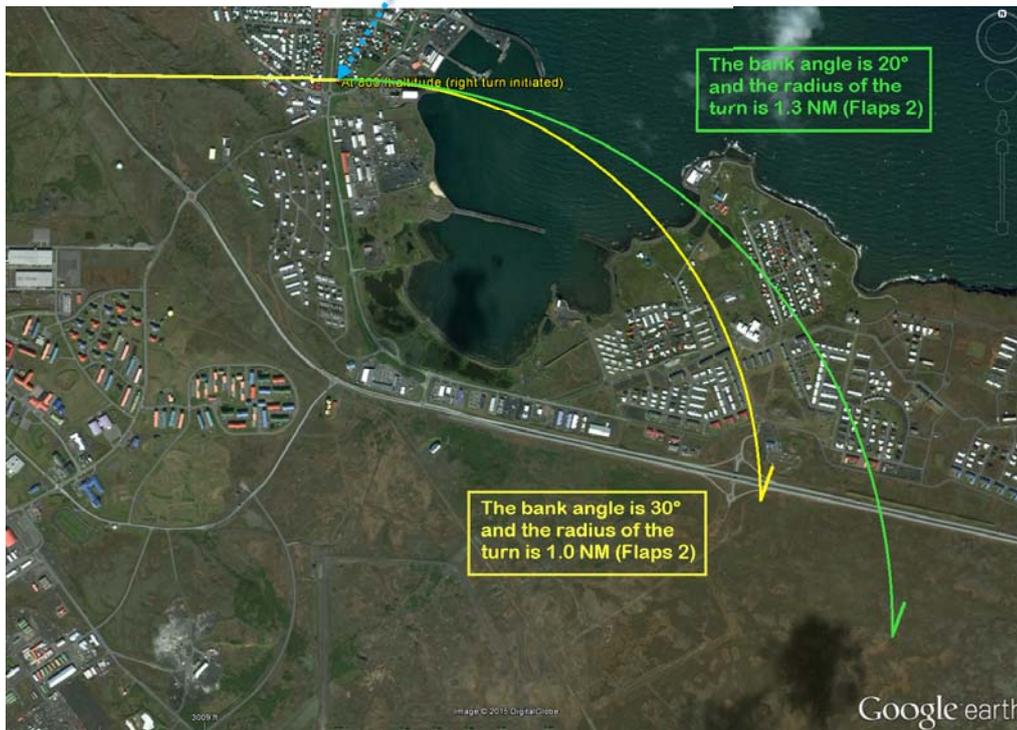
Figure 18: Turn based on right turn at 800 feet altitude for 20° / 30° bank angle
