Final report on aircraft serious incident

Case no.: **19-158F043**

Location: **Keflavik Airport (BIKF)**

Description: **Runway Excursion**

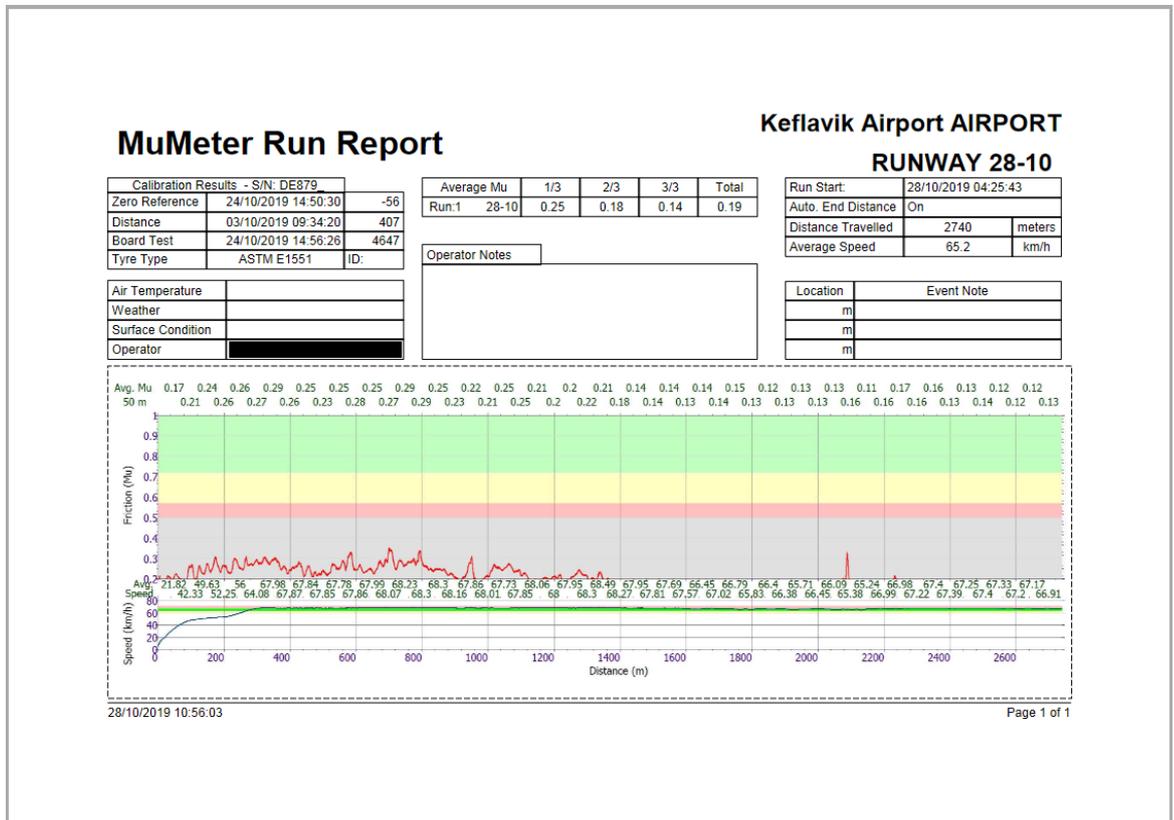
4) Braking measurement at 04:25AM RWY 28-10

- Runway 10/28 had not received any runway de-icing fluid during the night
- The last measured braking measurement at runway 10/28 had shown poor braking conditions
 - At 04:25AM RWY 10-28 braking measurement 0.25/0.18/0.14 with a total of 0.19
 - Per ICAO Annex 14, 0.25 and below is poor braking action
