### Final report on aircraft serious incident

Case no.: **17-018F005**

Date: **23. February 2017**

Description: **Declaration of an emergency due to low fuel**

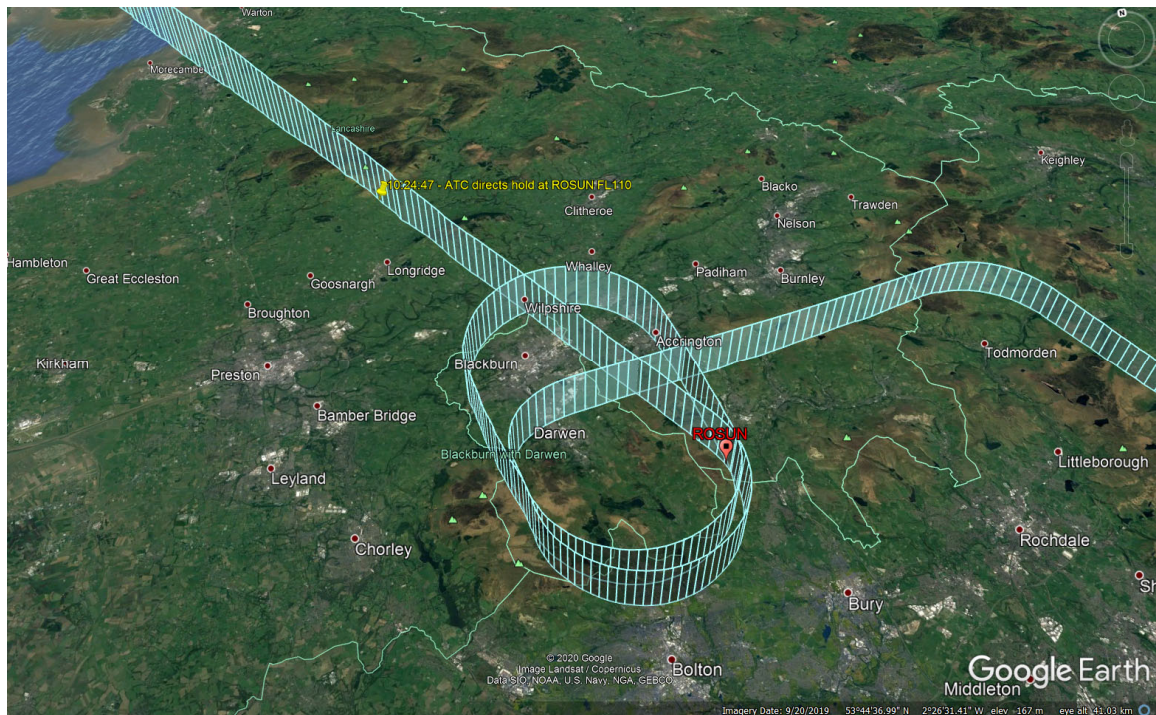
**Figure 1: Holding at ROSUN at FL110**

The flight crew of flight FI440 then informed Manchester Radar that they were entering a holding and would report their intentions within a few minutes (see Figure 1).

According to the Commander, he became aware of the actual severity of the weather conditions, resulting in multiple go-arounds at Manchester Airport, when instructed to hold at ROSUN FL 110.

The flight crew of flight FI440 completed one and a half holding pattern at ROSUN at FL110, discussing the situation and the option of diverting to Liverpool Airport (EGGP), before deciding to attempt an approach to Manchester Airport. The flight crew also decided that if they could not land at Manchester Airport due to the high wind condition, they would divert directly to Liverpool Airport. The flight crew informed Manchester Radar of their intentions.

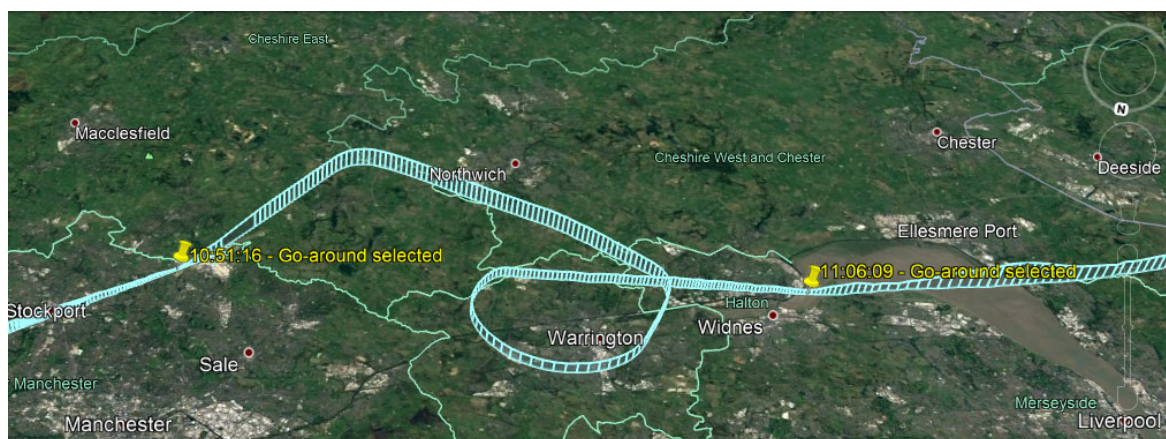
**Figure 2: Go-around at Manchester, through the Liverpool localizer and then a go-around**

At 10:57:31, the flight crew requested to Liverpool Radar to be taken through the localizer for a 270° right turn to the approach, as they were a bit high and still setting up the approach. Liverpool Radar approved this request and instructed them to turn right heading 360°.

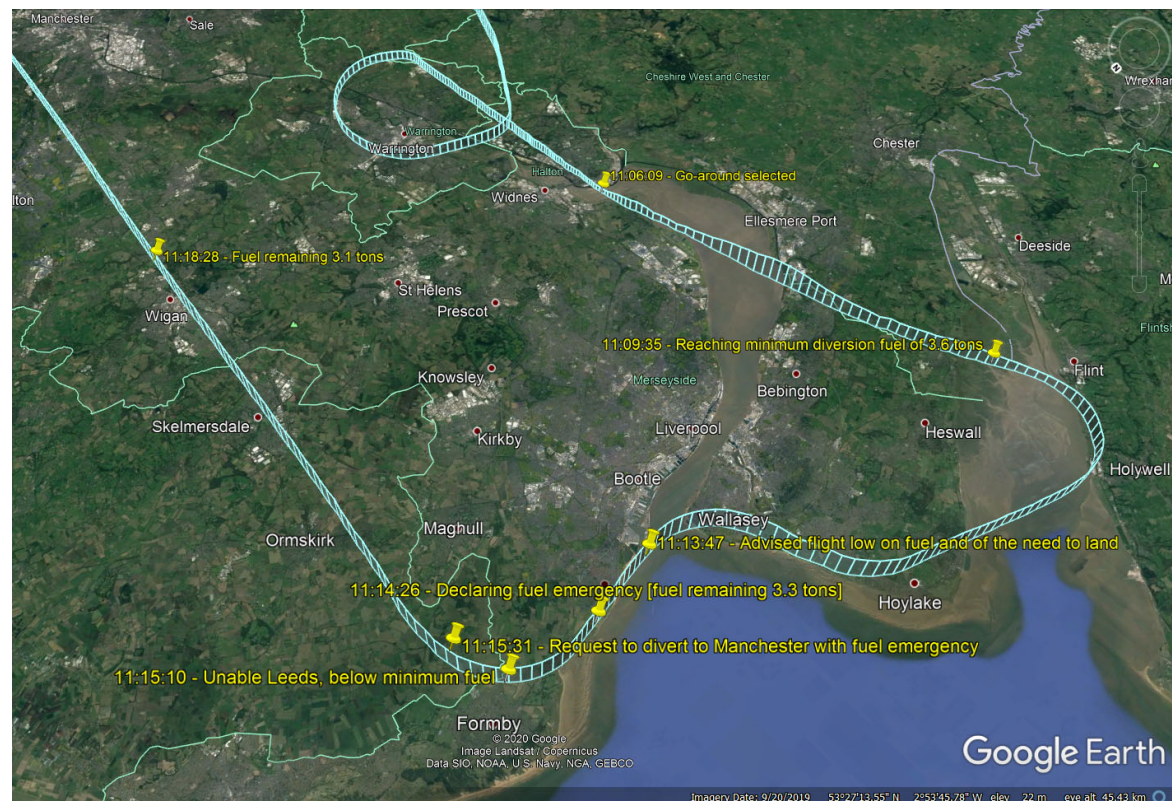
**Figure 3: Diversion to Liverpool, go-around at Liverpool and the fuel emergency thereafter**

Scottish Control then inquired the flight crew into the remaining on-board fuel. The flight crew of flight FI440 responded [at 11:18:28] that they had 3.1 tons [of fuel] remaining.

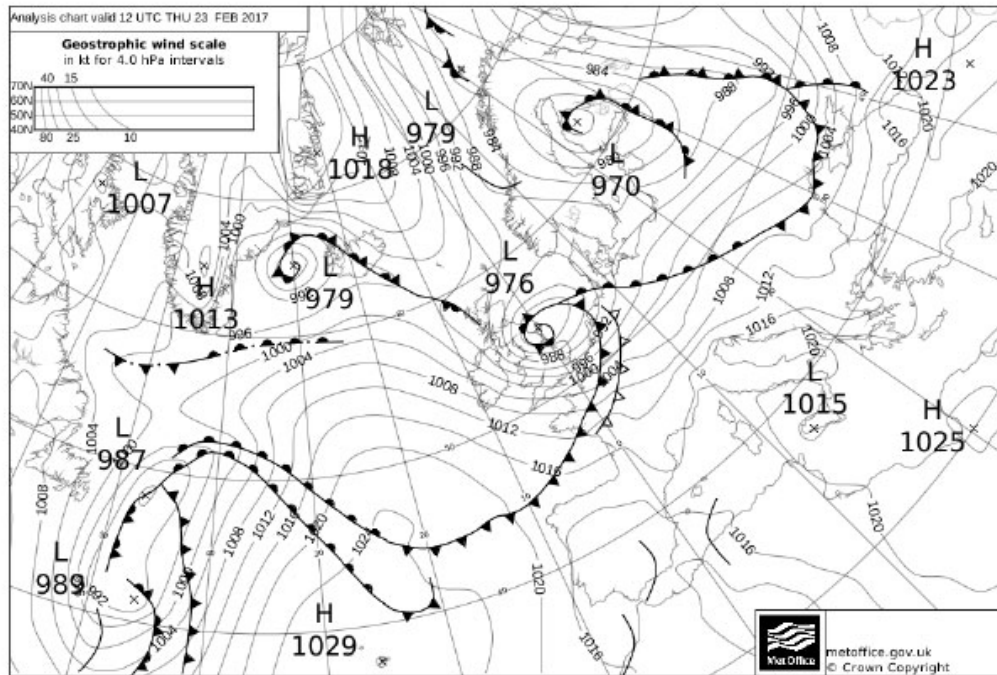
Figure 1. Surface analysis chart valid at 1200UTC on 23<sup>rd</sup> February 2017.

**Figure 1.** Surface analysis chart valid at 1200 UTC on 23<sup>rd</sup> February 2017. This shows a deep low pressure system (storm Doris) centred over North East England. Associated fronts circulate the low, and the tight isobars indicate a strong cyclonic flow around the low pressure system, with a NW flow over North West England.

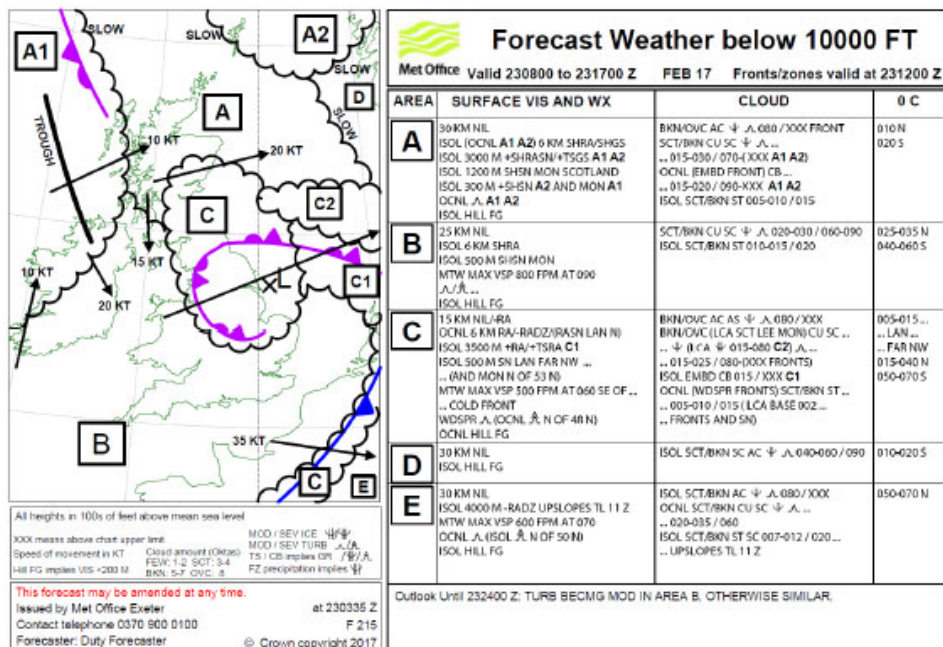
Figure 2. F215 Chart Valid between 0800UTC and 1700UTC on 23<sup>rd</sup> February 2017.

**Figure 2.** F215 Chart valid between 0800 UTC and 1700 UTC on 23<sup>rd</sup> February 2017. Zone C lies over the area of interest at this time, with area B approaching from the west. The chart suggests thick frontal cloud in zone C, with bases generally in the 500-1000FT range, but as low as 200FT on the fronts themselves. Occasional rain was forecast. The chart also indicates widespread moderate low level turbulence and isolated severe turbulence north of N4800, an area encompassing North West England. Zone B moving into the area suggests SCT/BKN amounts of convective cloud with higher bases than one C, with isolated showers of rain, but the risk of moderate/severe low level turbulence remains.

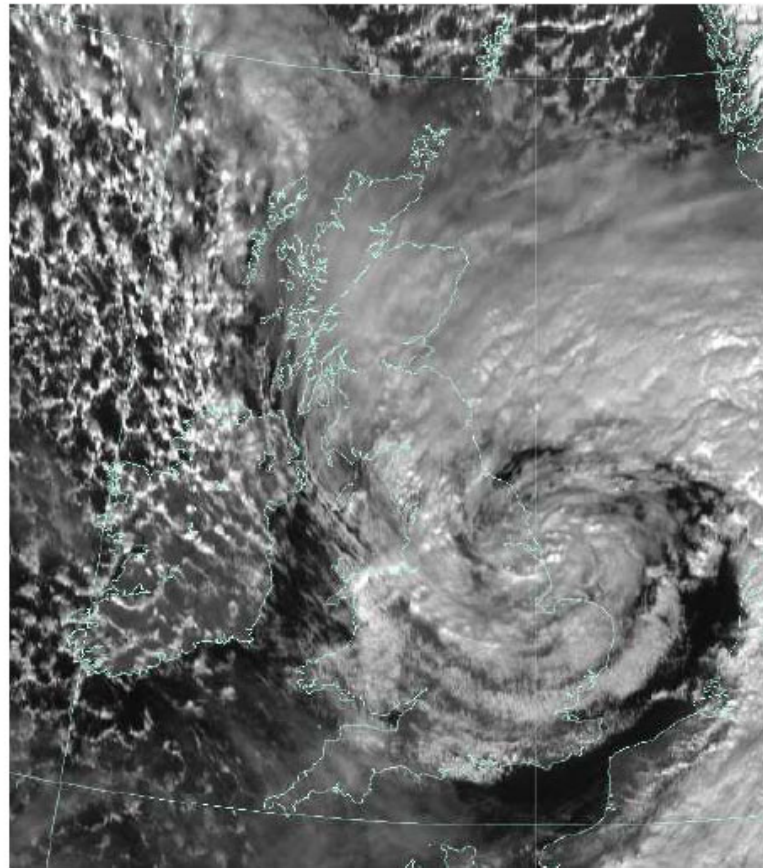
Figure 3. High resolution MSG Visible satellite image valid at 1200UTC on 23<sup>rd</sup> December 2017.

**Figures 3 and 4.** High resolution visible satellite imagery valid at 1200 UTC on 23<sup>rd</sup> February 2017. Satellite imagery shows storm Doris centred over Northern England with thick frontal cloud circulating around the low pressure system. Figure 4 shows some brighter, lumpier cloud over north west England, suggesting some convection embedded within the frontal band. The open cell convective cloud to the west of the storm, over Ireland at this time, is indicative of a strong flow.

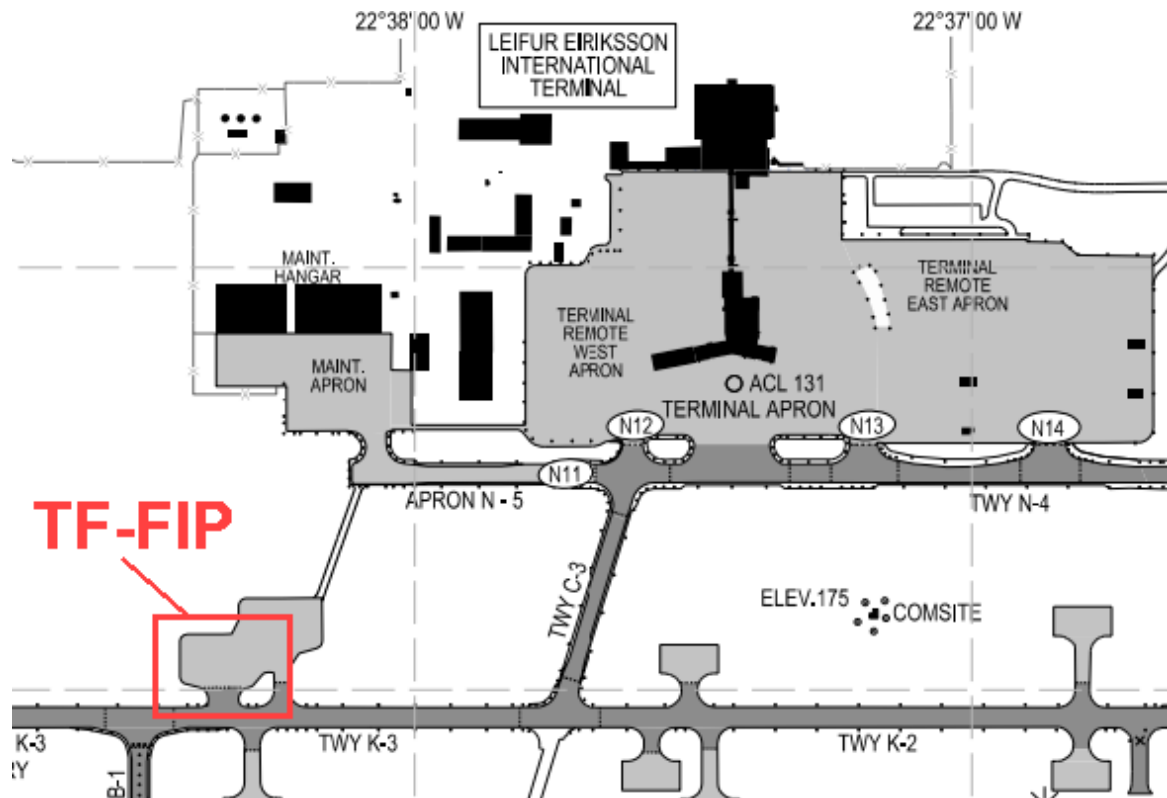
Figure 8: Location of aircraft TF-FIP at Keflavik Airport before the flight

According to the Commander, he entered the cockpit just over 30 minutes before scheduled departure.

Based on the FDR, the aircraft was located at a remote stand, requiring additional time for the flight crew to reach the aircraft compared with if it had been at the terminal.
