Case: **21-001F001**

Location: **Taxiway Bravo at Keflavik Airport (BIKF)**

Description: **Aircraft slid off taxiway**

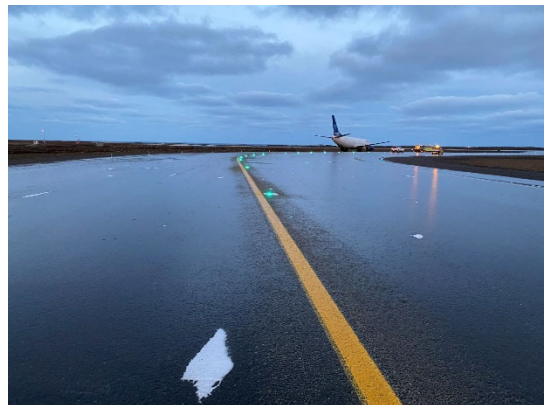
According to the flight crew of flight 3998, the braking action on RWY 28 was good. Once the aircraft was turned onto taxiway Bravo (TWY B-1), as instructed by ATC, the braking action became very poor.

The Commander realized the aircraft did not turn as commanded to the right on taxiway Bravo, regardless of the tiller being turned completely to the right, resulting in the aircraft sliding off the taxiway.
