LOKAÐ MEÐ BÓKUN

Case.: **21-035F006**

Location: **Reykjavik Airport, RWY 13**

Description: **Landing mishap**

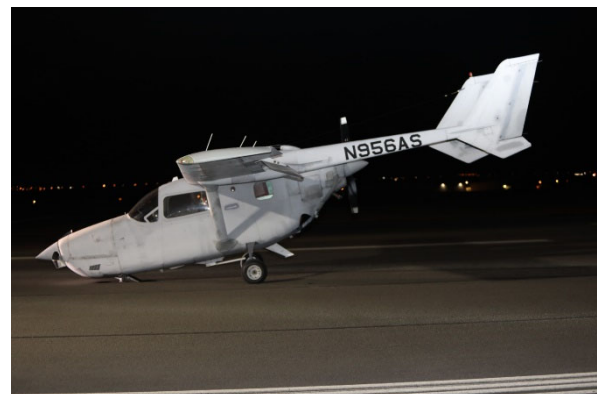
Aircraft N956AS (Cessna T337H) was being ferried across the Atlantic accompanied by another aircraft of the same type (N952AS). During the ferry flight, a fuel stop was scheduled at Reykjavik Airport (BIRK) late in the evening of April 12th.

According to a witness, when aircraft N956AS landed on RWY 13, it bounced during the landing and then the nose landing gear collapsed.
