LOKAÐ MEÐ BÓKUN

Case no.: **22-110F022**

Location: **Enroute to Ísafjörður (BIIS) from Akureyri (BIAR)**

Description: **Right nacelle fuel filter drain failure**

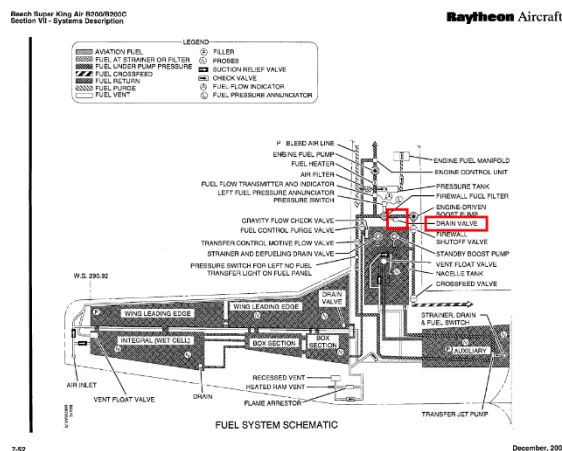
After landing it was discovered that the right nacelle firewall fuel filter drain, on the lower side of the cowling forward of the firewall, had failed and was missing its core part. As a result, the right-wing fuel tank drained completely, and the right engine shut down due to fuel starvation (Figure 2-4).

Figure 2: Failed drain valve located just forward of the firewall on lower side nacelle cowling
