DIRECTORATE OF CIVIL AVIATION

AIRCRAFT ACCIDENT REPORT

TF-RAN, SIKORSKY S-76A

8 NOVEMBER 1983

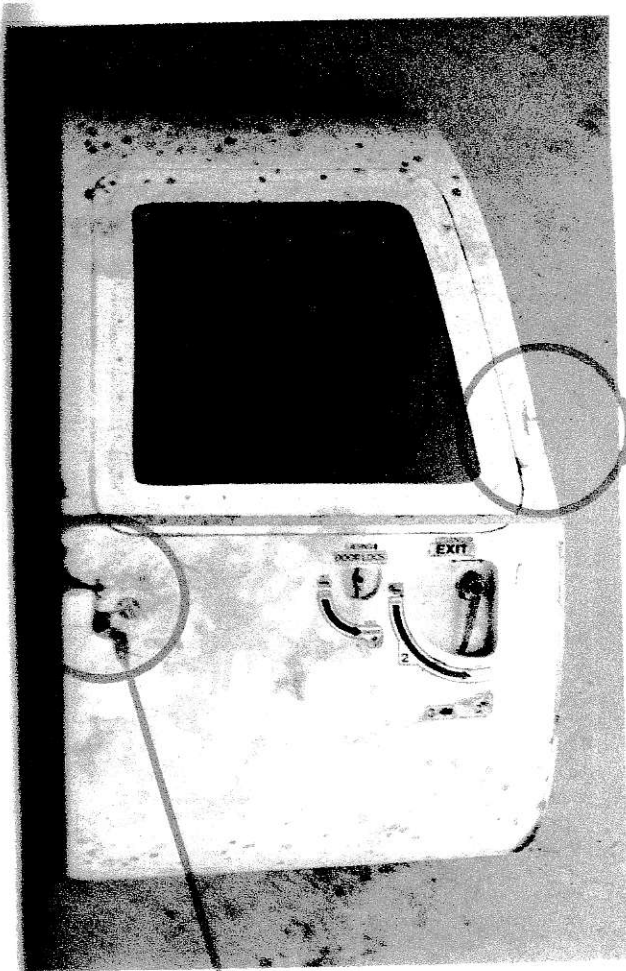
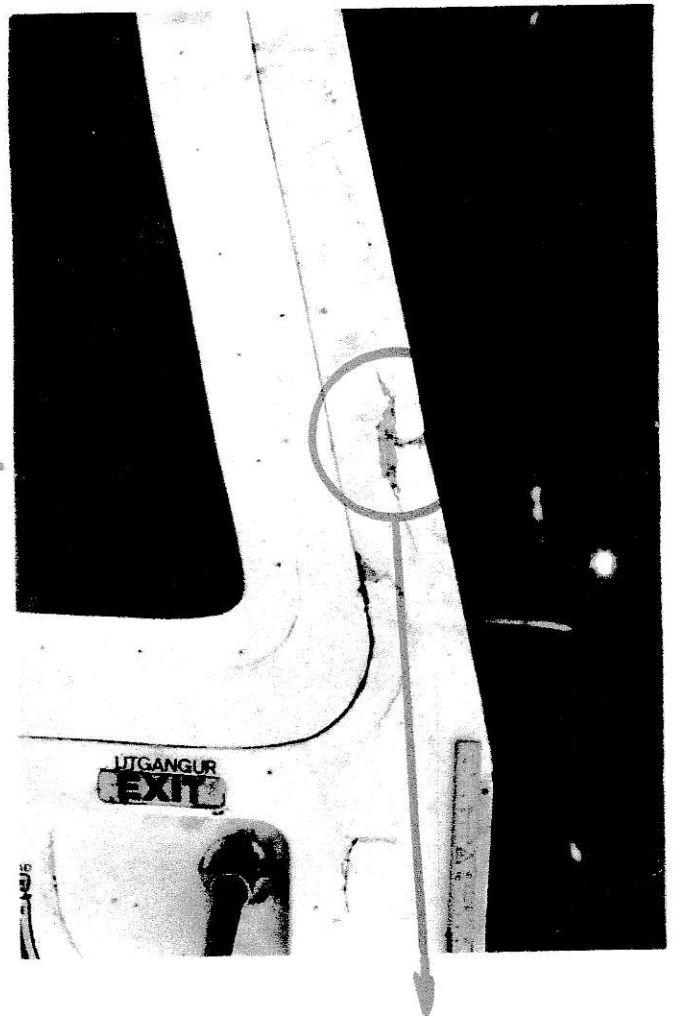
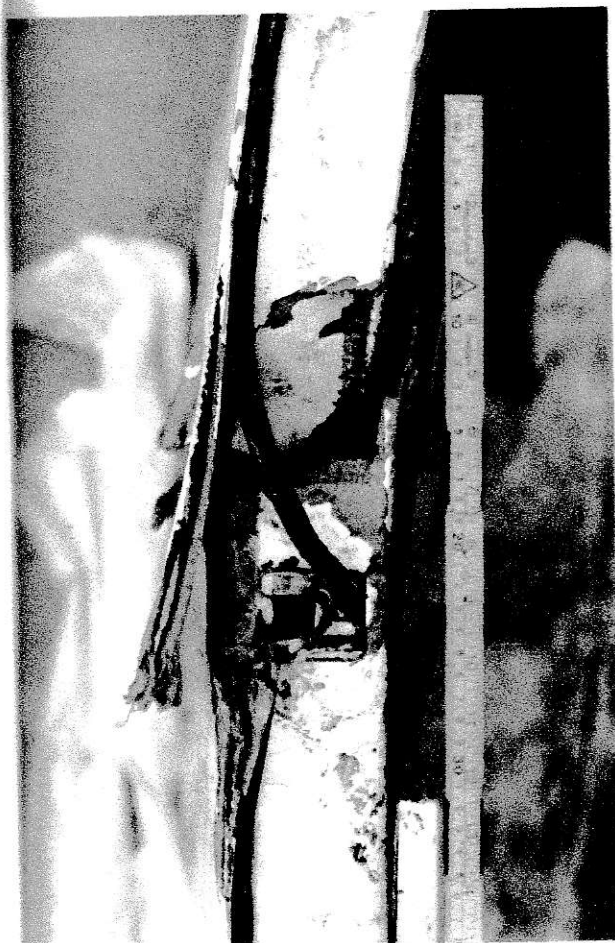
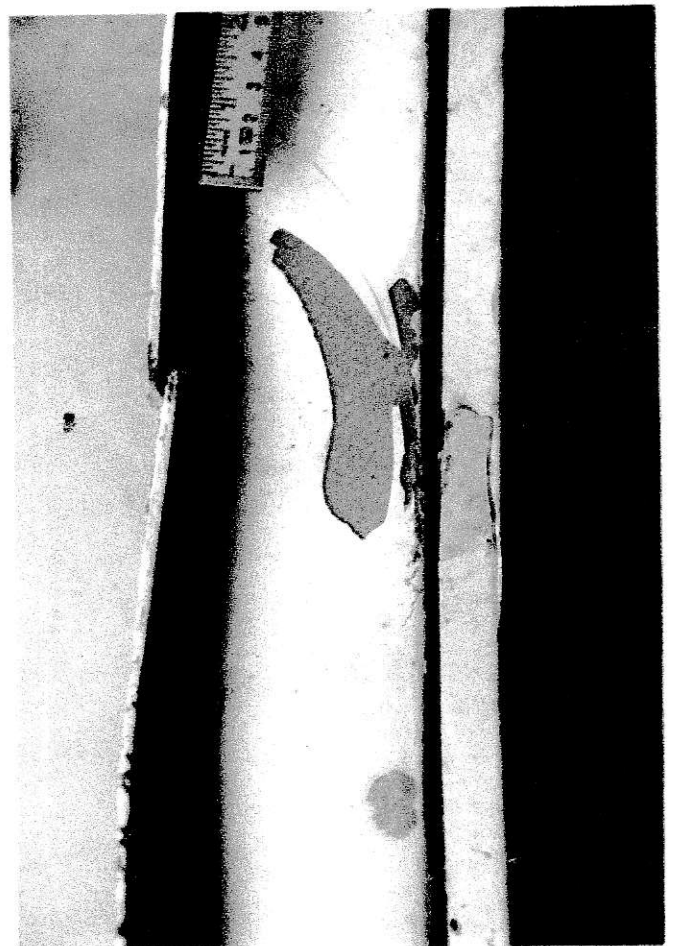
FIGURE 1

As illustrated in Figure 1, two main areas of damage were present. The most severe was in the region of the catch on the door's aft edge, this taking the form of localised crushing and failure of the door edge structure. This damage was consistent with the door being struck by a long slender object, from the aft direction, sufficiently hard to break through the door edge and distort part of the latch mechanism.

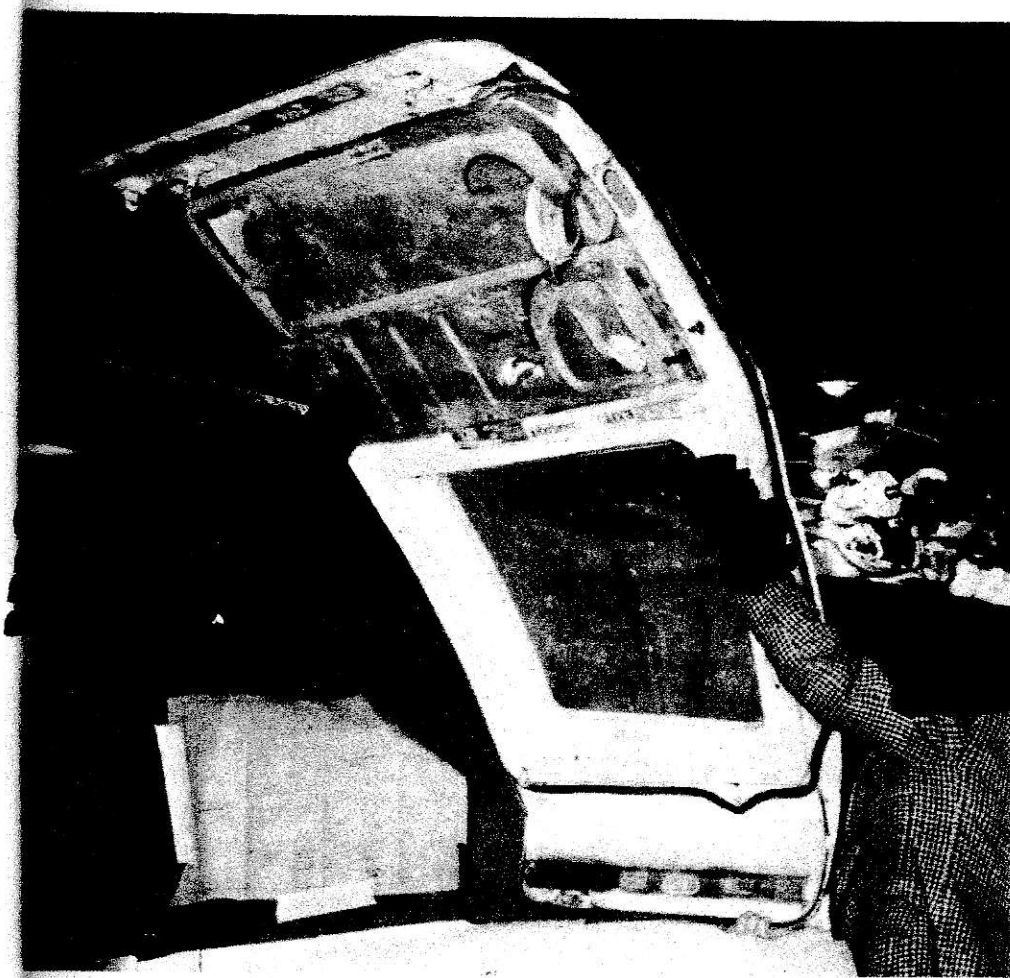
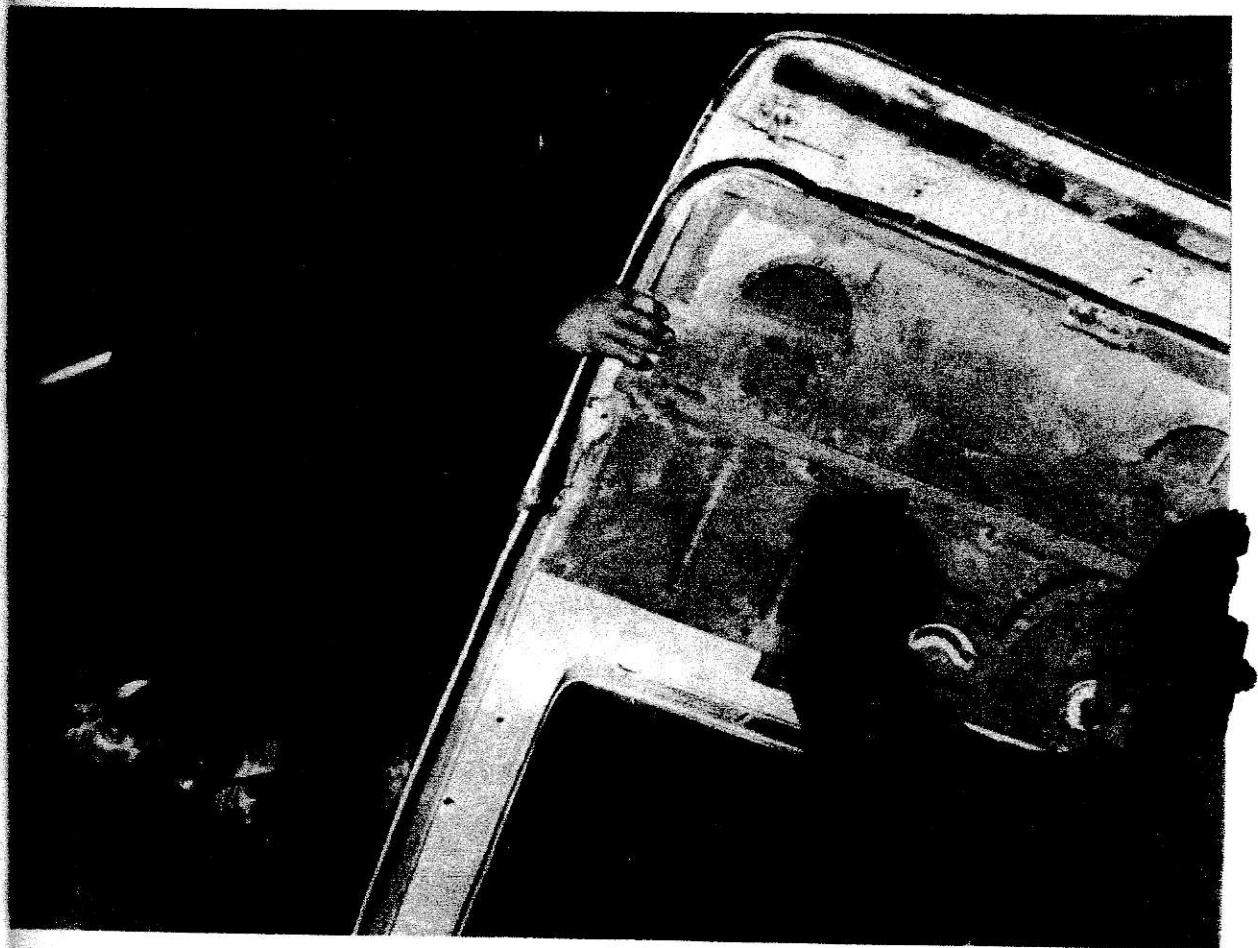
FIGURE 3

4.1 The door from TF-RAN was offered up to a serviceable S76 in a variety of positions and photographed. It readily became apparent that the major area of damage across the door's aft edge was consistent with a MRB strike, with the door in a similar position to that shown in Figure 3. As seen, the point of contact, with the advancing blade at approximately 45° to the fuselage axis, of door and blade was some 35" out from the blade root. However, if the coning angle of the blades in flight and disc tilt is taken into account and the door rotated further upwards about its upper edge, then this point of contact moves inboard towards the 18" position. Also, the angle of cut across the door was very close to that of the blade leading edge in this position.

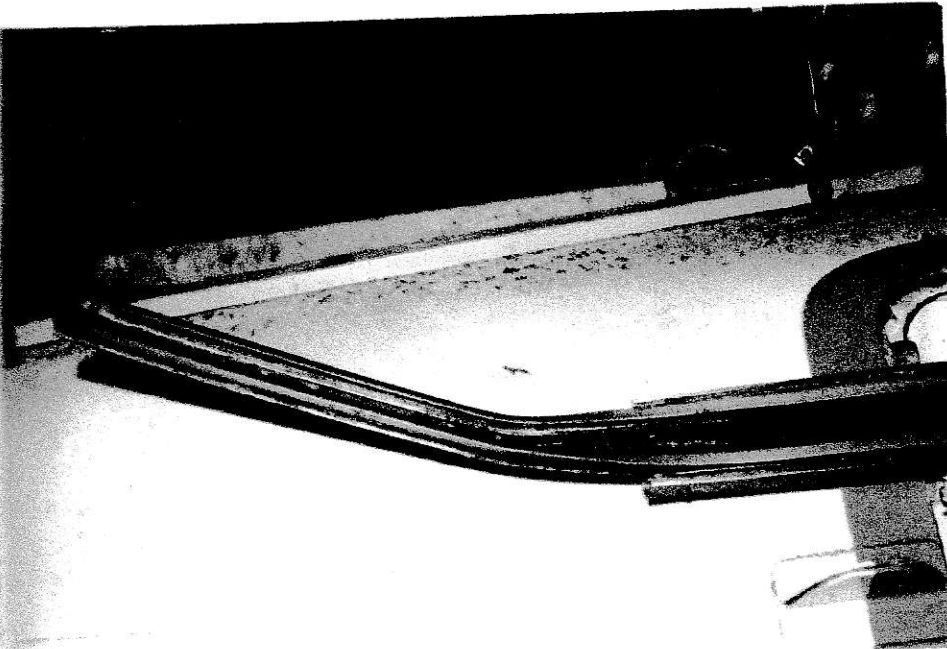
FIGURE 4

A copy of a photograph showing the door upper intermediate telescopic rail and localised fuselage damage on TF-RAN is included as Figure 4, for reference.

Figure 4 shows the door upper intermediate rail after the accident. The distortion of the rail, its position and localised fuselage damage both indicate the rail to have been fully extended as the door pivoted upwards. In addition, damage caused to the upper inner rail by the balls exiting the tracks was

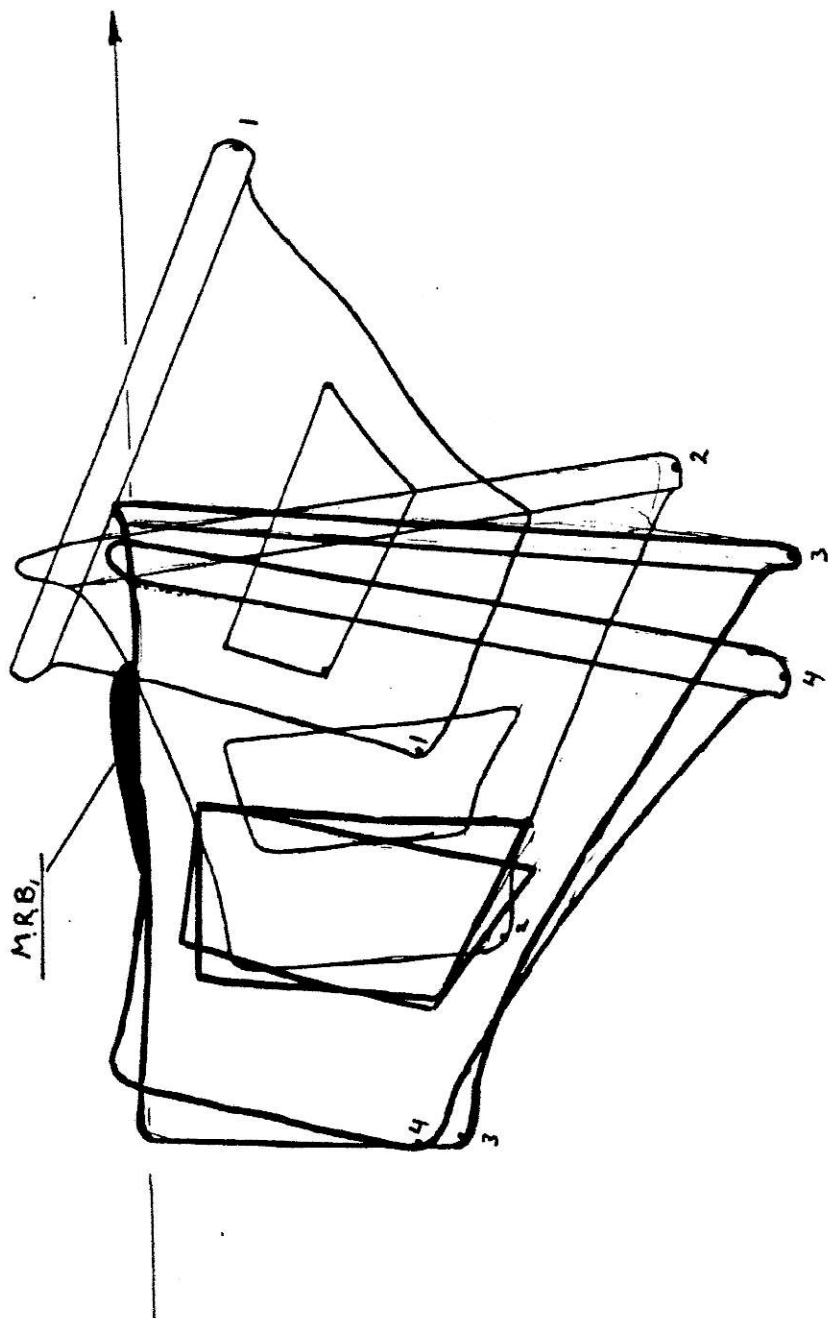
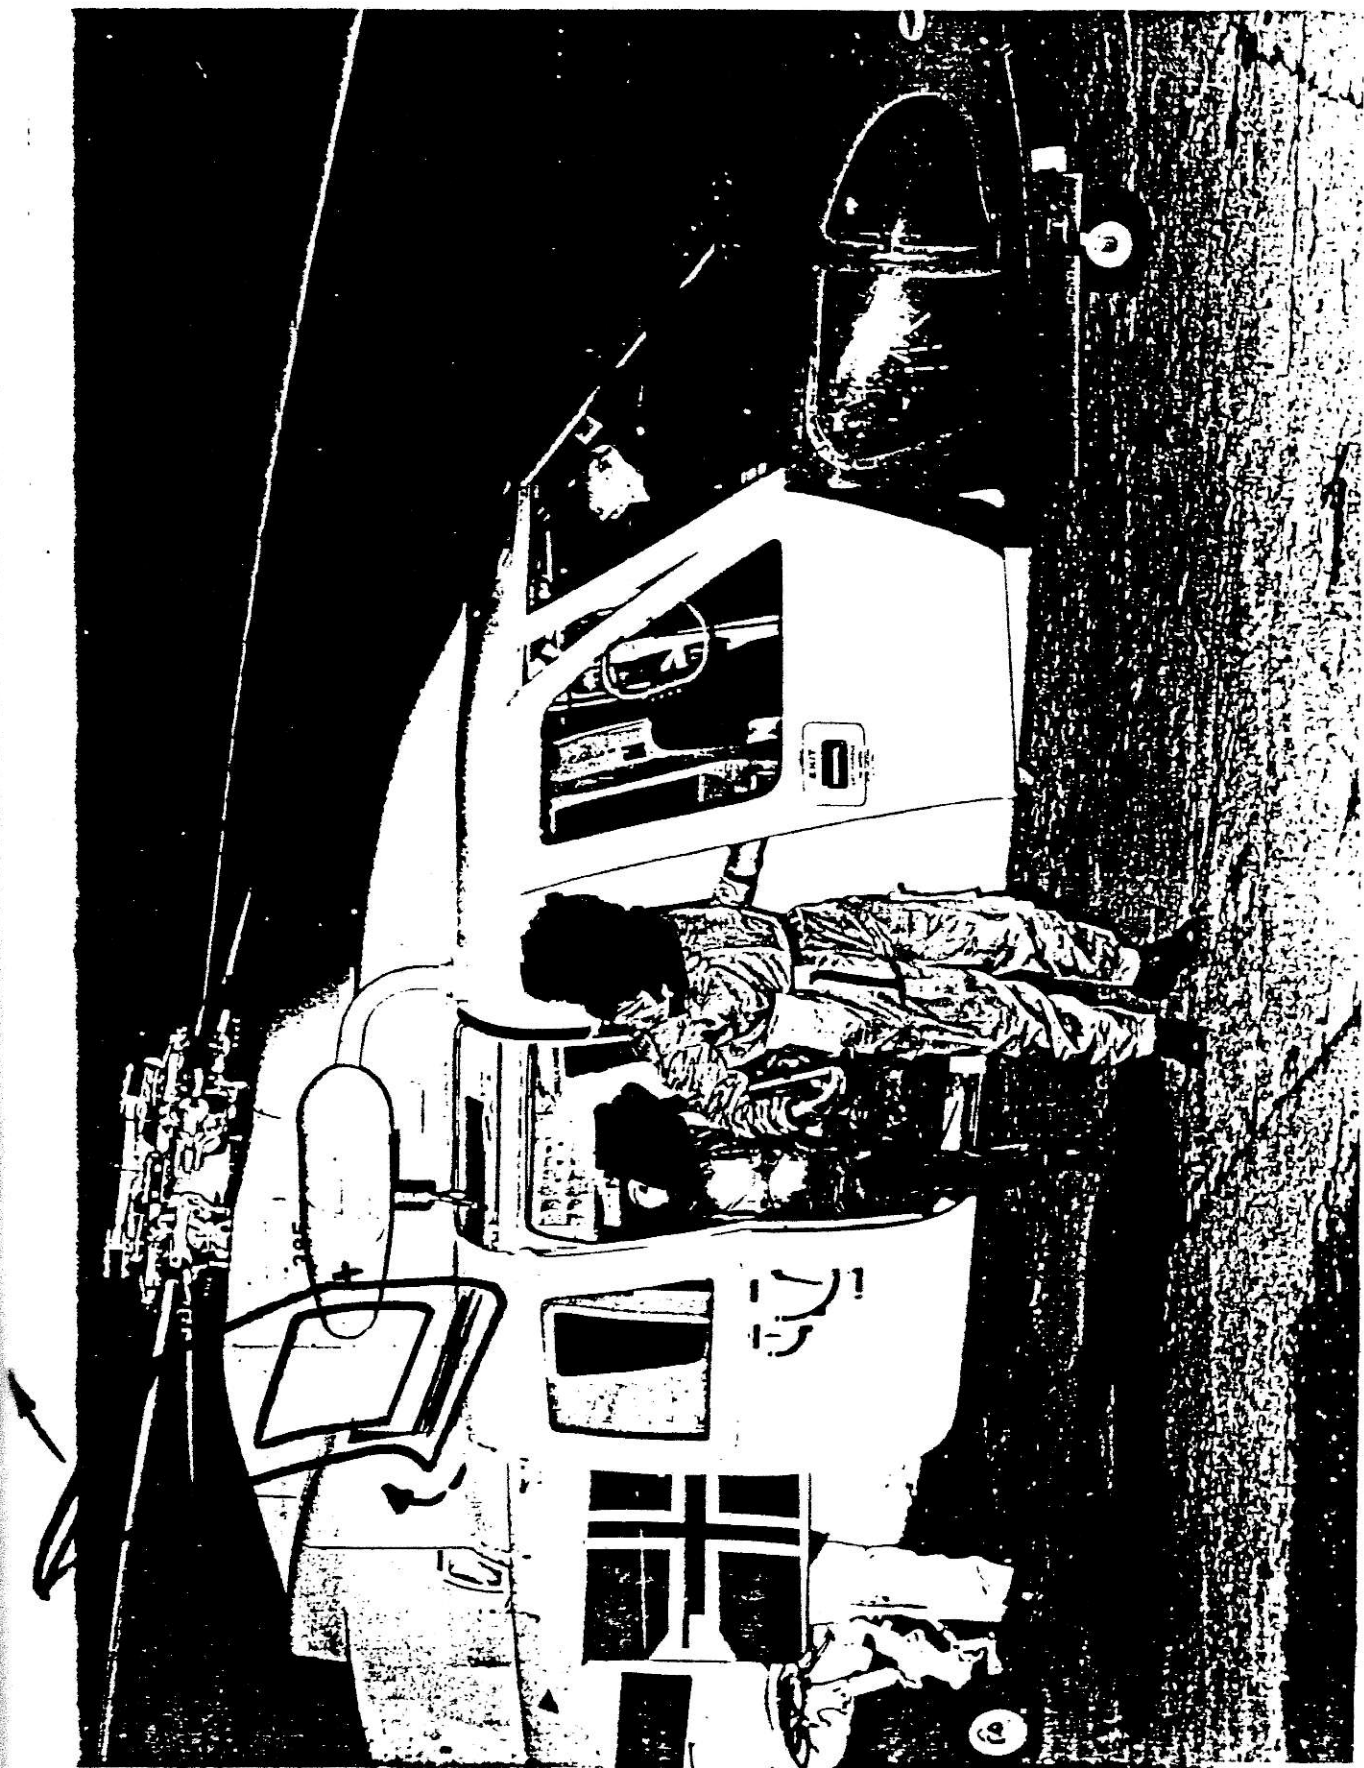
FIGURE 7

4.2 The sequence described in paragraphs 4.1 and 4.2 does not explain the lesser damage present on the door leading edge. The S76 used in these tests was not fitted with the winch installation, as was TF-RAN. If the likely position of this winch is considered, then it would seem possible for the door L/E to have struck the aft portion of the winch fairing, possibly in the manner shown in Figure 7.

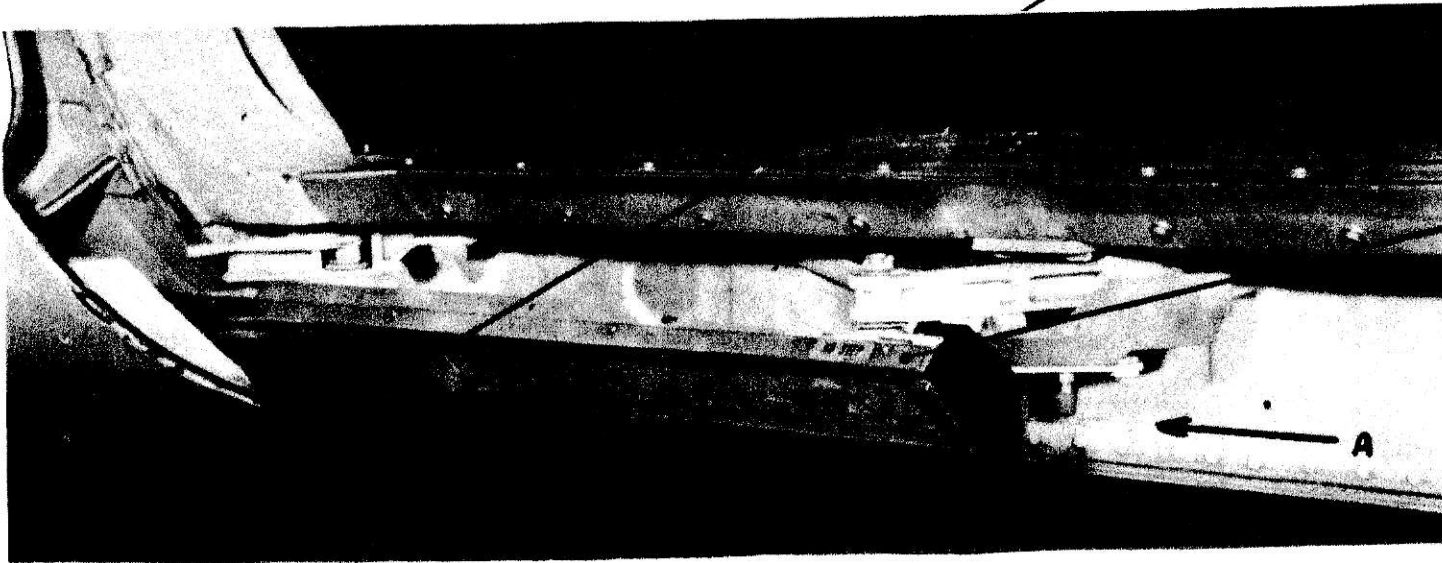
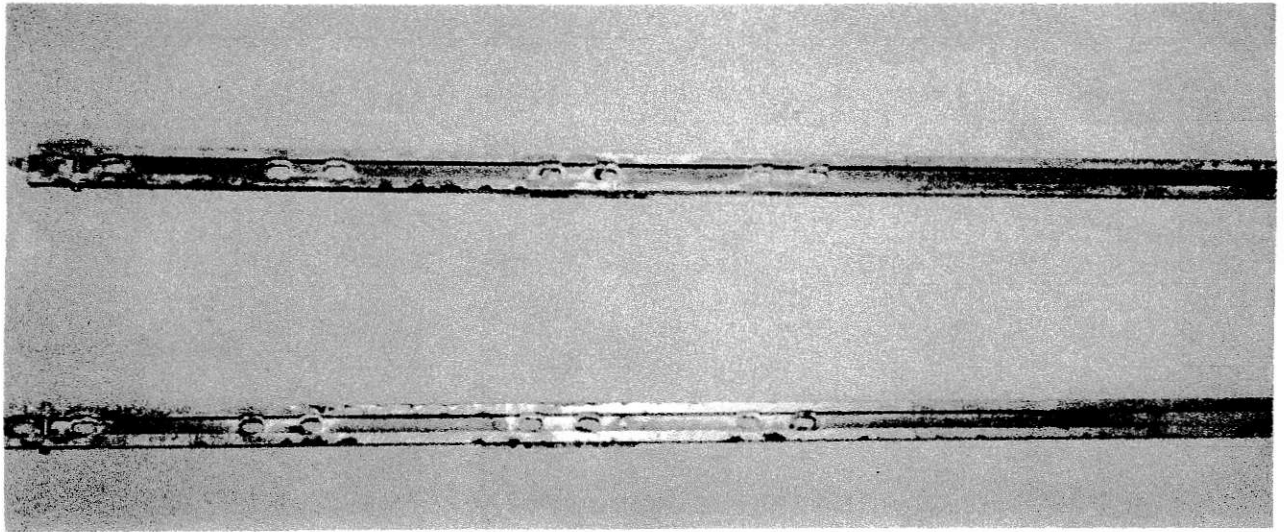
FIGURE 9

Only the inner rails, those attached to the door, were available for direct examination and these are shown in figure 9.

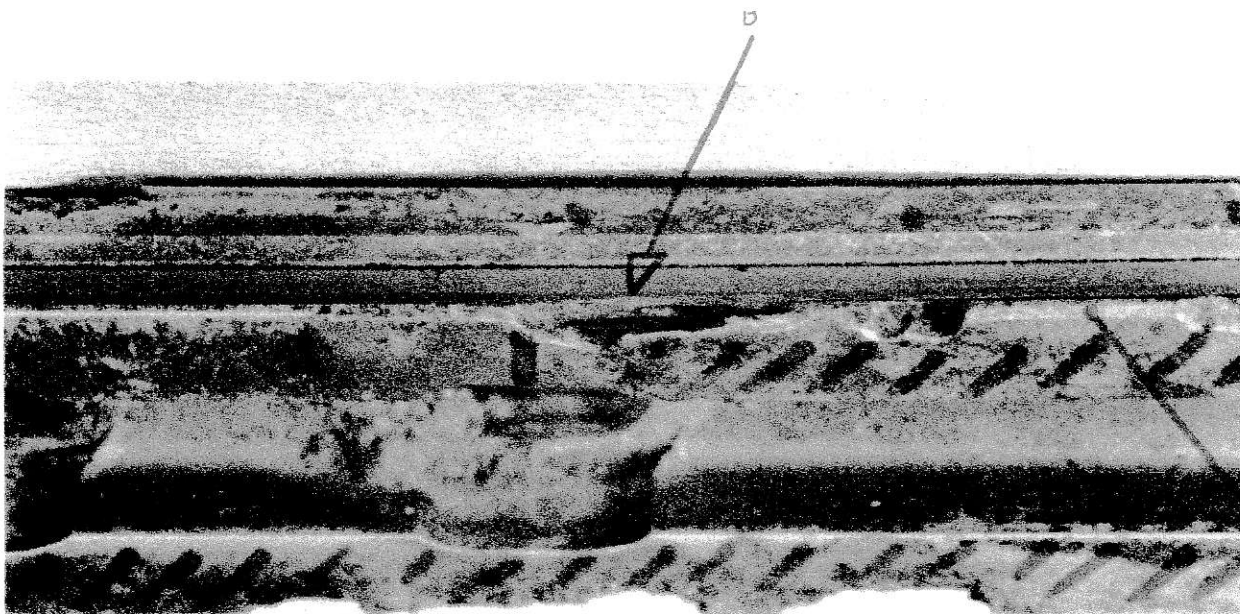
FIGURE 10

The nature and position of damage on the lower rail, however, was significantly different. As may be seen from figure 10, the regions over which the balls have exited each track are staggered, the lower set of balls being displaced by some 3 ball pitches towards the door open position by comparison with the upper set. This set was positioned approximately 4.2" from its end stop.

TRACK EDGE DEFORMATION ON OUTER EDGE

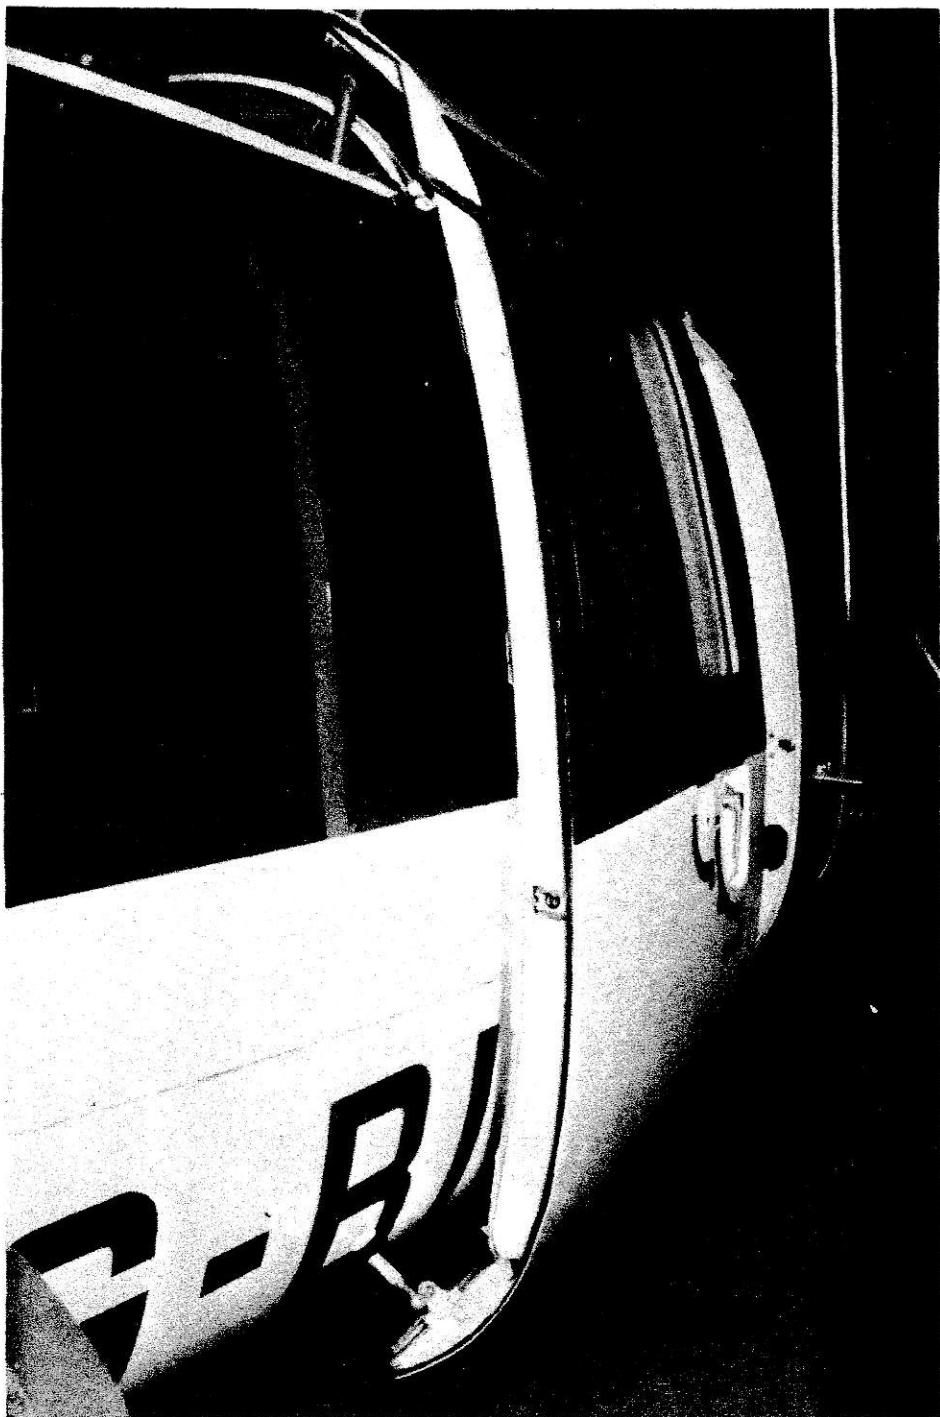
FIGURE 12

approaches its fully open position the intention is that two spigots, mounted from the fuselage, engage with two nylon eyes, mounted from the door, in order to provide lateral and vertical support for the door aft end, figure 12.
