## CLOSED WITH A BOOKING

Case number.: **23-073F024**

Location: **At Varanasi airport in India**

Description: **Tail strike during landing**

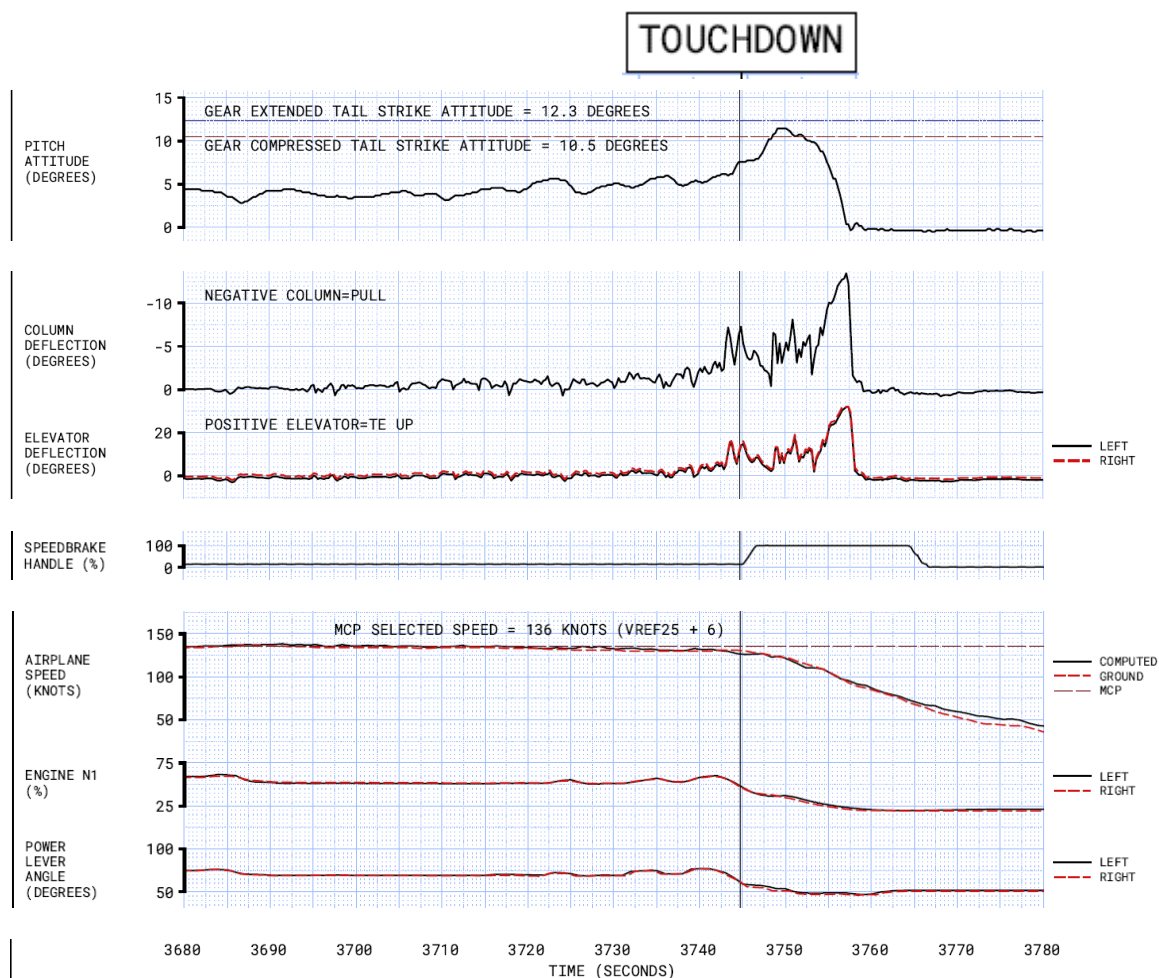
Í þjálfunarhandbók flugmanna<sup>5</sup> er tekið fram að hjól flugvélarinnar ættu ekki að snerta flugbrautina (touchdown) á hraða sem er lægri en Vref-5 hnútar. Einnig<sup>6</sup> er tekið fram að við landingu á hraða sem er 10 hnútum undir áætluðum landingarhraða (Vref -10) sé hætt á að reka stél flugvélarinnar niður í flugbrautina við landingu (touchdown). Flugvélin var hins vegar yfir þessum hraða þegar aðalhjól hennar snertu flugbrautina klukkan 05:38:44 (Vref-3).

Í þjálfunarhandbók flugmanna<sup>7</sup> er tekið fram að til að forðast það að stél flugvélarinnar rekist niður í flugbrautina skuli passa að kink (pitch) flugvélarinnar aukist ekki eftir að aðalhjólin snerta flugbrautina (touchdown).

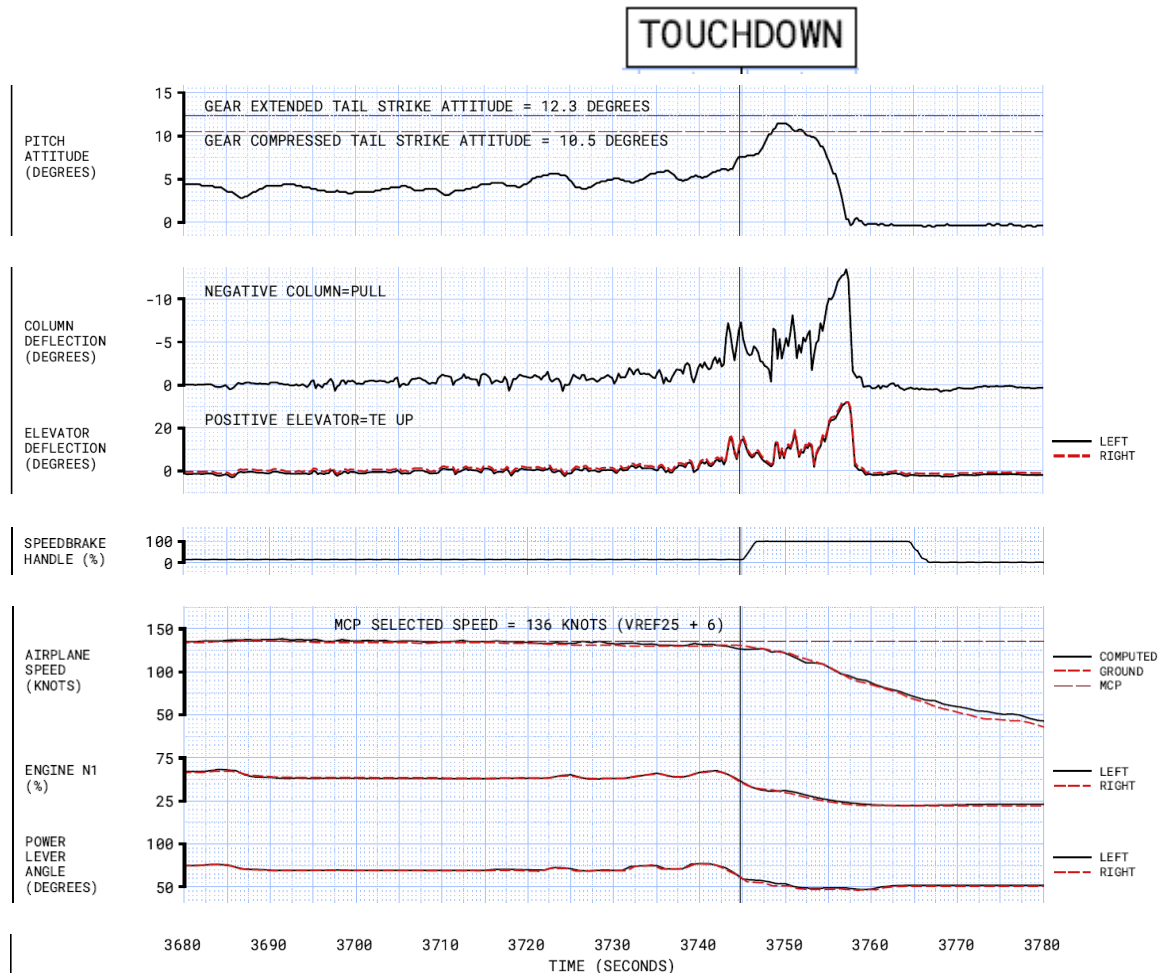
In the FCTM<sup>5</sup> it is discussed that touchdown should not occur at air speeds below Vref-5 knots. In addition<sup>6</sup> it is discussed that landing at air speed that is 10 knots below Vref (or Vref -10), there is a risk of a tail strike during touchdown. The aircraft was however above this air speed (it was at Vref-3) when its main wheels touched the runway during the landing at 05:38:44.

In the FCTM<sup>7</sup> it is also discussed that to avoid a tailstrike, the pilot needs to ensure that the pitch attitude does not increase after touchdown.
