Final report on aircraft serious incident

Case no.: **23-016F005**

Date: **13. February 2023**

Description: **Uncontrolled descent**

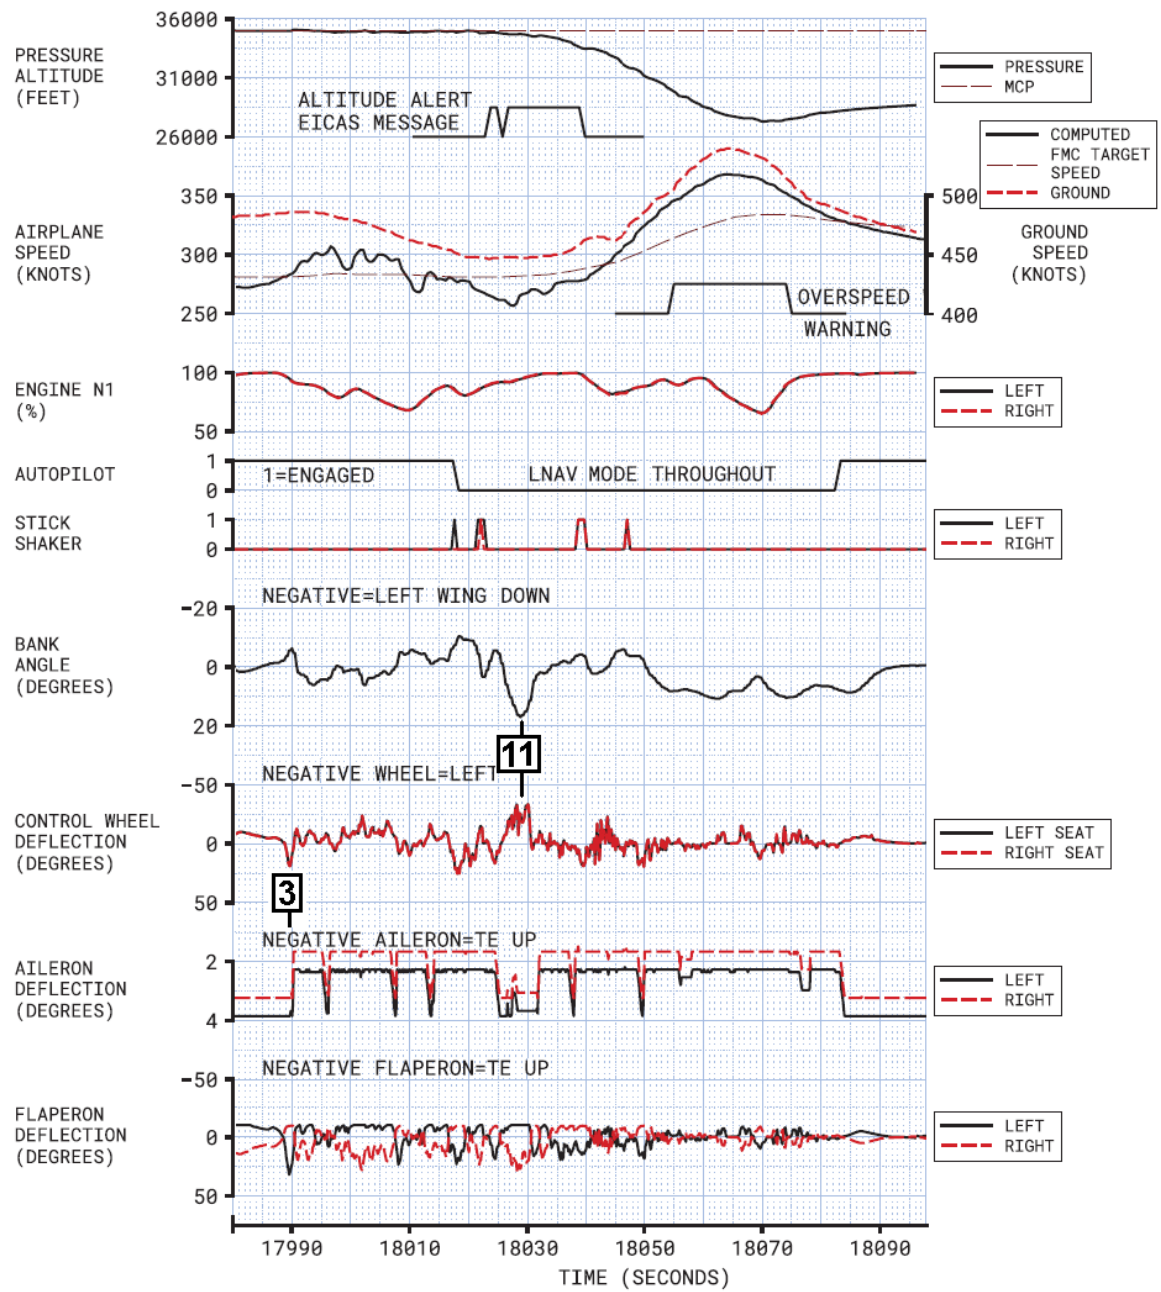
Figure 24: FDR parameters.

- 11) At 08:10:18 UTC (timestamp 18,027 in Figure 23, Figure 25, Figure 24 and Figure 27), the lowest airspeed and Mach during the descent was reached, at 256 knots and 0.76M respectively. At this point, a maximum forward thrust was commanded, the pitch attitude continued to decrease, and airspeed began to increase again. The First Officer (PF) continued to push on the control column as the airspeed was increasing and the airplane pitch attitude was approaching 10 degrees nose down. The airplane reached a bank angle of 17 degrees to the right, which the flight crew countered with an opposing control wheel deflection of approximately 35 degrees.

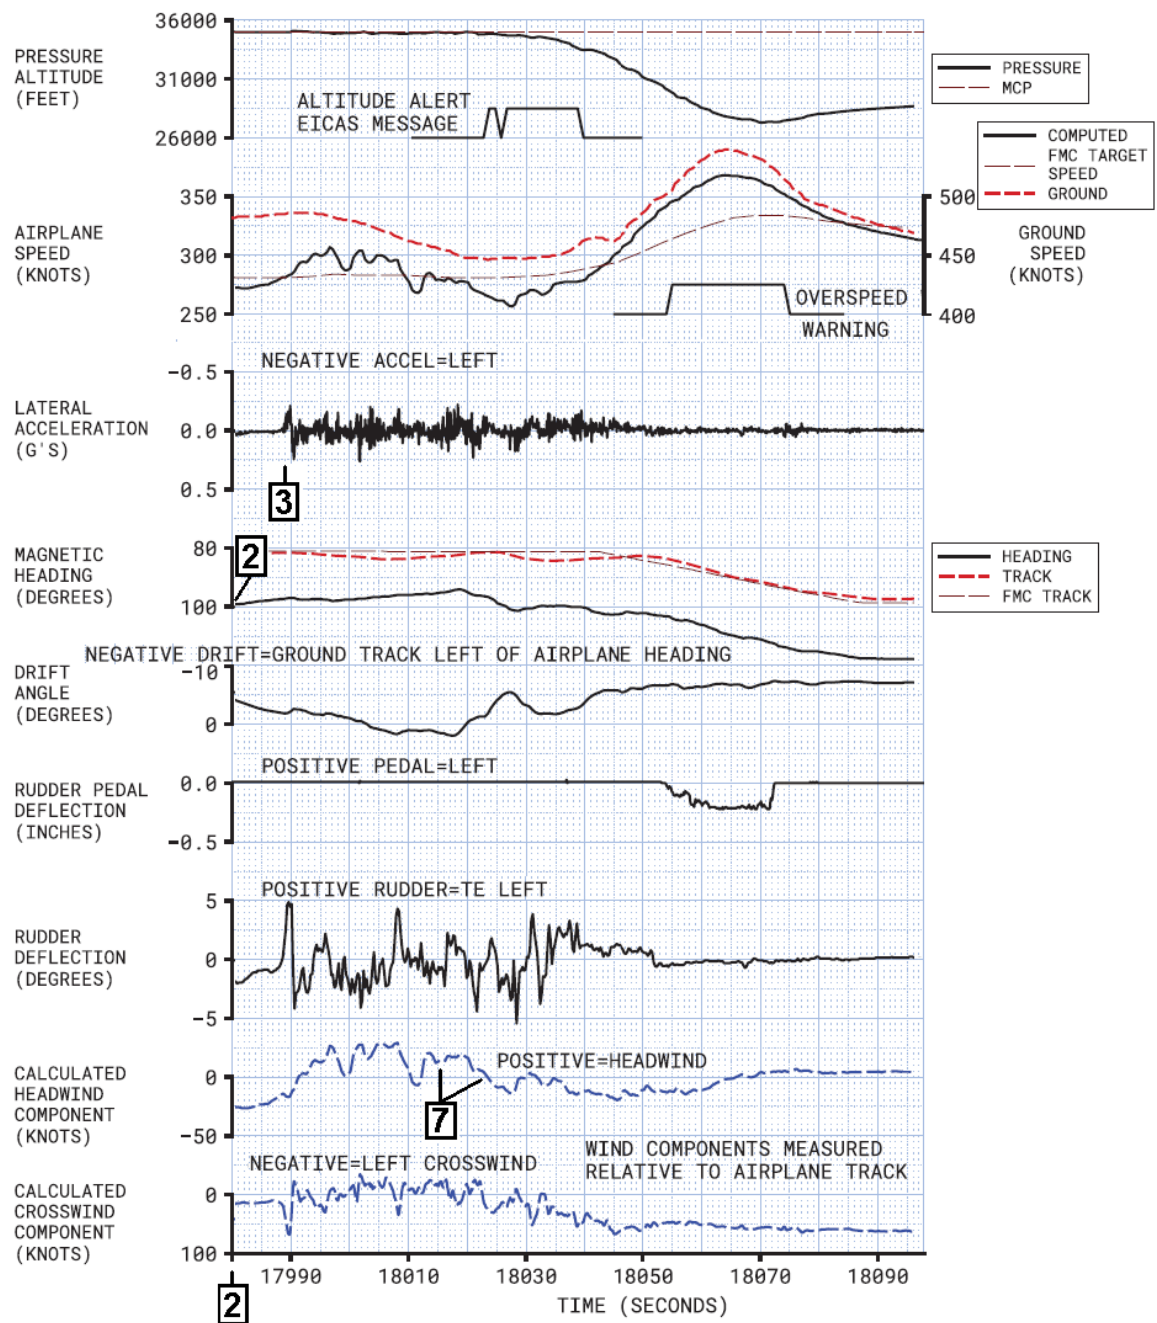
Figure 25: FDR parameters.

- 2) At 08:09:31 UTC (timestamp 17,980 in Figure 25), the aircraft heading started to deviate to the left, indicating increased wind from the left side. The Mode Control Panel (MCP) selected heading had been changed by the flight crew just over two minutes prior and continued to follow the FMC track.

- 3) At 08:09:40 UTC (timestamp 17,989 in Figure 23 to Figure 25 and Figure 27), oscillations in acceleration and angle of attack, the airspeed began to increase, indicative of a turbulence encounter. An initial increase in vertical acceleration followed by a sharp decrease to near -1 g's occurred at the onset, simultaneous with an updraft followed by a rapid downdraft. The control column force data indicate that the First Officer (PF) started applying control column force at this time. The autopilot remained engaged. Symmetric aileron deflection trailing-edge-up occurred.

- 7) At 08:10:06 UTC (timestamp 18,015 in Figure 23, Figure 25, Figure 25 and Figure 27), the aircraft altitude was 34,971ft, the speed was 0.82M, or 279 knots, and the aircraft had started descending with V/S of -272fpm. A further TRA reduction to nearly idle which allowed N1 to decrease, even as A/T subsequently began to increase TRA, in combination with the still deployed speedbrakes and a headwind component change contributed to the airspeed reducing an additional 20 knots over the next 7 seconds. The Master Warning began to intermittently engage for the next 65 seconds, mostly aligned with activations in the Altitude Alert Engine Indication and Crew Alerting System (EICAS) message, Overspeed Warning.

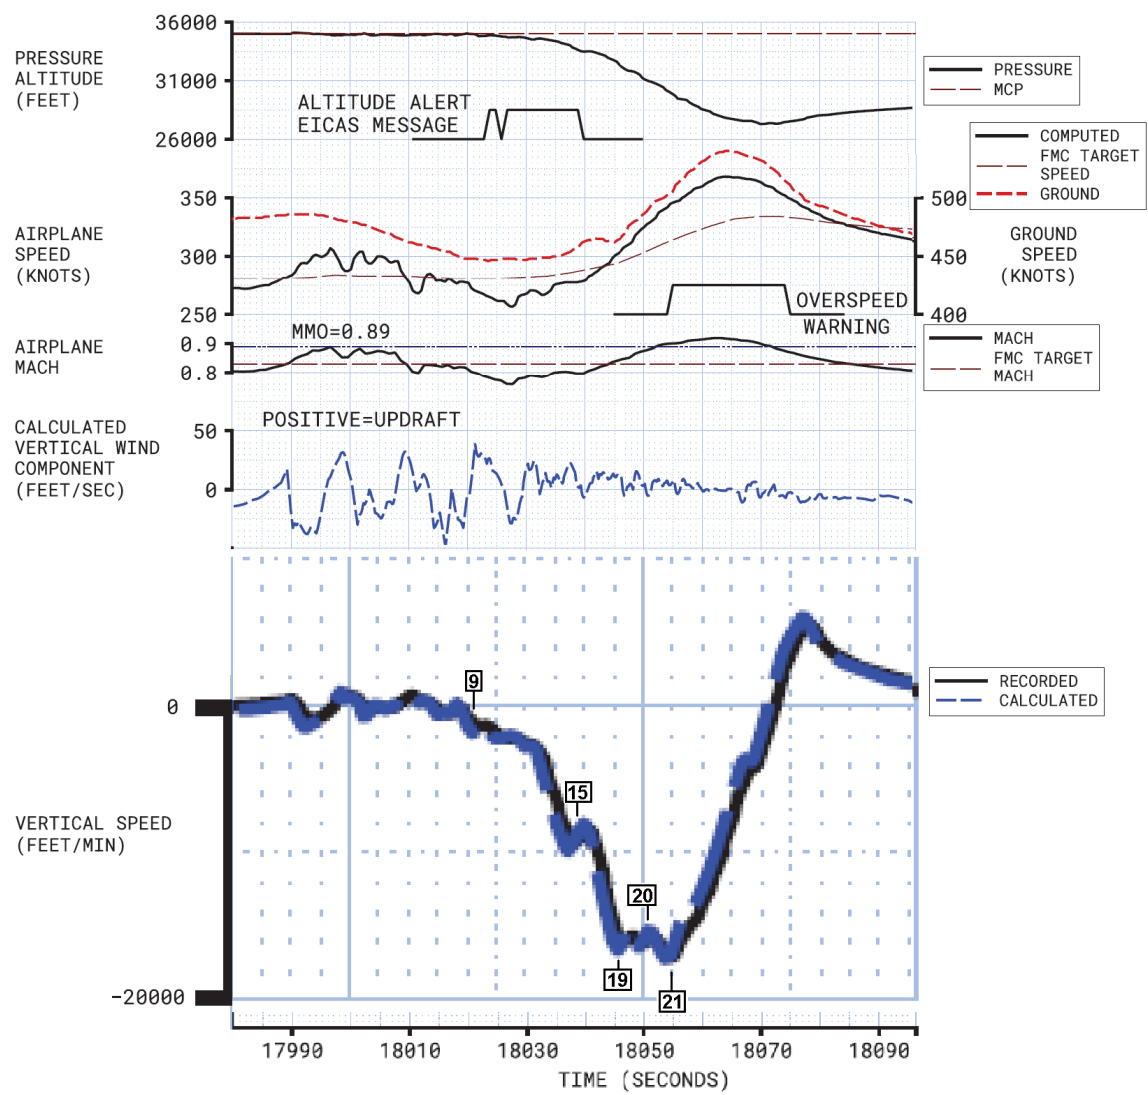
Figure 26: FDR parameters

- 9) At 08:10:12 UTC (timestamp 18,021 in Figure 23, Figure 23, Figure 26 and Figure 27), the stick shaker activated for the second time. The speed was 0.788M, or 268 knots, the vertical acceleration was 0.5g and aircraft started to descend with V/S of -1360fpm.

- 15) At 08:10:29 UTC (timestamp 18,038 in Figure 23, Figure 26 and Figure 27), the third stick shaker activation occurred. This was at speed 0.79M, with V/S -9008fpm and 0.559g vertical acceleration.

- 19) At 08:10:37 UTC (timestamp 18,046 in Figure 23, Figure 23, Figure 26 and Figure 27), while descending through 32,000ft, the fourth activation of the stick shaker was recorded. The aircraft speed had exceeded 300 knots, its vertical speed (V/S), or descent rate, was -15,920fpm and the vertical acceleration was 1.06g. The Captain (PM) applied a control column pull of nearly 100 pounds while the First Officer (PF) applied a control column push of 100 pounds, causing the two control columns to breakout from each other.

20) At 08:10:42 UTC (timestamp 18,051 in Figure 23, Figure 23, Figure 26 and Figure 27), the aircraft exceeded its maximum operating speed (VMO/MMO) at 30,692ft, with -15,952fpm.

21) At 08:10:45 UTC (timestamp 18,054 in Figure 26 and Figure 27), the Captain (PM) applied a control column pull of 130 pounds, as the aircraft exceeded its maximum operating speed (VMO/MMO), resulting in a pitch attitude increase. A maximum sink rate (V/S) of -17,100fpm was reached.
