REPORT ON SERIOUS INCIDENT

Case nr.: **22-042F006**

Location: **Enroute from Malaga, Spain, to Keflavik, Iceland**

Description: **Declared an emergency due to possible low fuel availability**

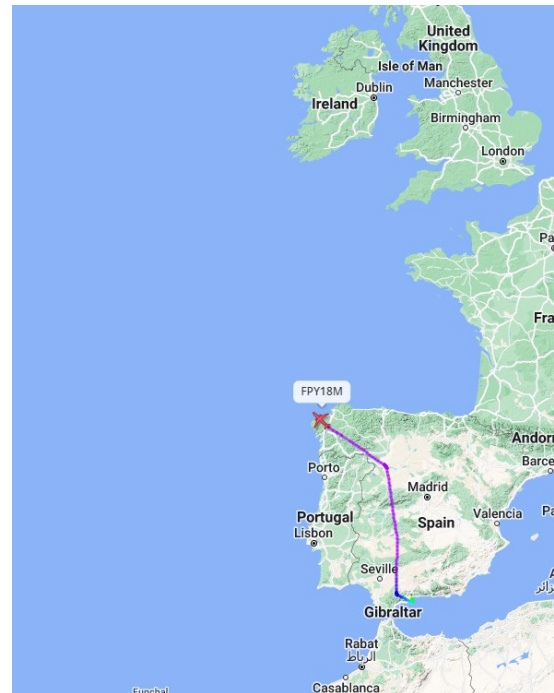
1. Autopilot OFF warning
2. Auto flight FAC 2 Fault
3. Auto flight FCU 2 Fault
4. Air conditioner control 2B Fault
5. Cabin pressure system 2 Fault
6. Fuel FQI channel 2 Fault
7. Brake system 2 Fault

Figure 1: Location of the aircraft at 22:26, when the error messages were displayed.

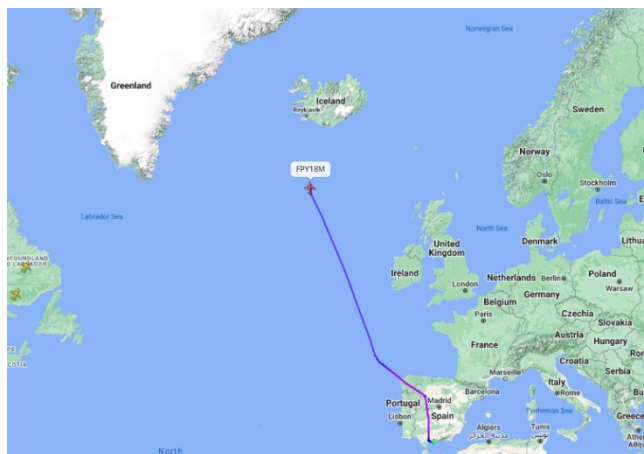
At 00:56, when the aircraft was about to reach 60° North, the flight crew contacted Reykjavik Control (Figure 2). They explained the situation to the Air traffic controller and declared an emergency.

Figure 2: Location of the aircraft when the crew declared an emergency.

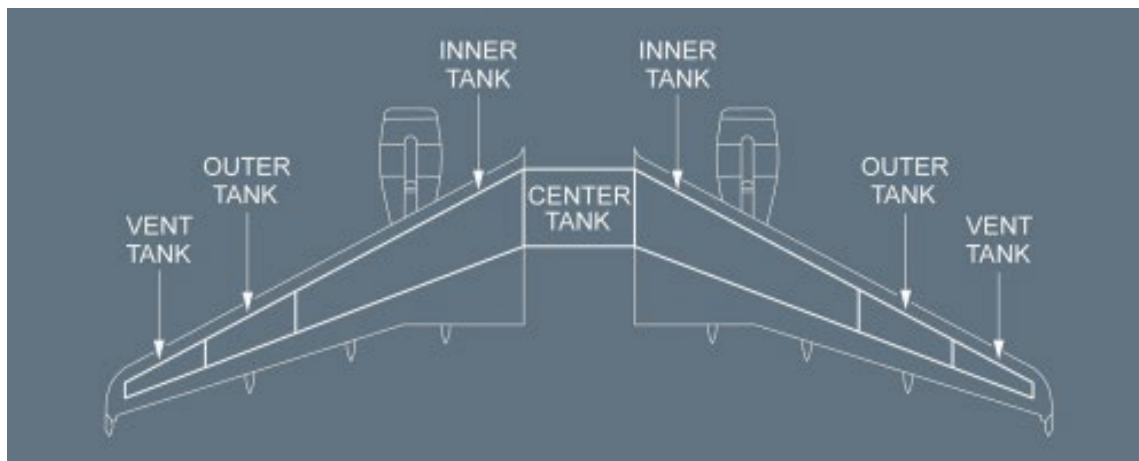
Figure 3: Fuel tanks.

The aircraft has five fuel tanks and two vent tanks. In each wing there is one outer tank, one inner tank and one vent tank. In the centre wing box, there is one centre tank (Figure 3). Each inner wing tank holds 5,396 kg usable fuel, while each outer wing tank holds 678 kg usable fuel. The center tank holds 6,474 kg usable fuel, so the total usable fuel capacity is 18,623 kg. Fuel is fed to the engines from the inner wing tanks.

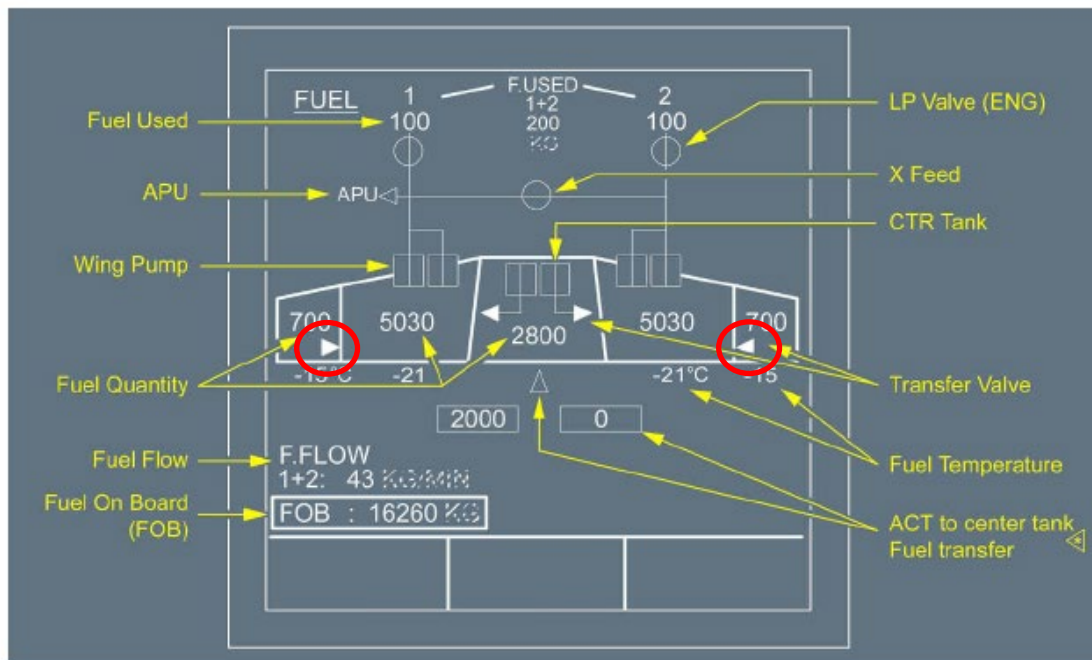
Figure 4: Operational aspects.

As stated above, the valves for the transfer of fuel from the outer tanks to the inner wing tanks open automatically when the fuel reaches 750 kg in the inner wing tanks (Figure 4).

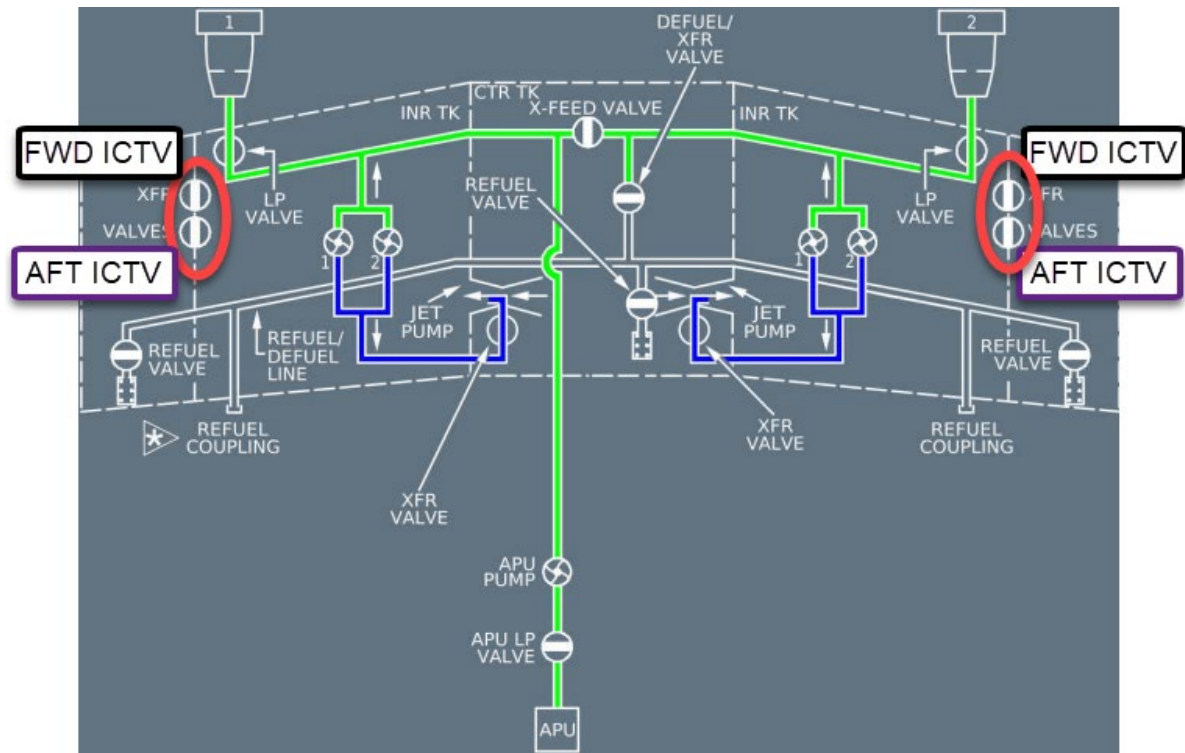
Figure 5: Fuel system schematic.

Each wing has two Inter Cell Transfer Valves (ICTVs) between the inner and outer tanks, one forward (FWD) and one AFT (Figure 5). When the inner tank fuel reaches a low level (approx. 750 kg), the two ICTVs in each wing automatically open, enabling fuel to transfer by gravity from the outer to the inner tanks.

The four ICTVs are paired into left and right FWD and left and right AFT. Each pair is commanded open when one of the two low fuel level sensors becomes dry, and both ICTVs in that pairing (FWD or AFT) open. Once open, the valves are latched open and automatically close during the next refuelling operation.
