**PRELIMINARY REPORT ON A SERIOUS INCIDENT WITH**  
**TF-FIO, ICELANDAIR FI-315**  
**22 JANUARY 2002 AT OSLO AIRPORT GARDERMOEN**

-type & reg.:	Boeing 757-208, TF-FIO
-year of man.:	1999
-engines:	RR RB 211-535E4
Radio call sign:	FI-315
Date and time:	January 22 2002 at 0949 hrs UTC
Location:	RWY 01L at Oslo airport Gardermoen
Type of occurrence:	Serious aircraft incident
Type of flight:	Scheduled commercial flight operation
Weather cond.:	METAR 0950Z: 36002 KT 2 700 –FZDZ BR FEW 001 SCT 002 BKN 003 M04/M04 Q0985 TEMPO 1 000 –FZDZ BR VV002=
Light cond.:	Daylight
Flight cond.:	IMC
Flight plan:	IFR
No. of persons onb. :	75 passengers and a crew of 7
Injuries:	None
Aircraft damage:	None
Other damage:	None
Commander	
-sex/age:	Male, age 43 years
-licence:	ATPL
-fl. experience:	Total flight time 8 034 hrs, 2 061 hrs on B757
Information sources:	Commanders “Voyage Report”, First Officers “Flight Occurrence Report”, the company’s Standard Operating Procedure (SOP), Flight Recorder Data (FDR), Senior Cabin Attendants report, taped communication between the aircraft and Gardermoen TWR, radar readout and several passenger reports.

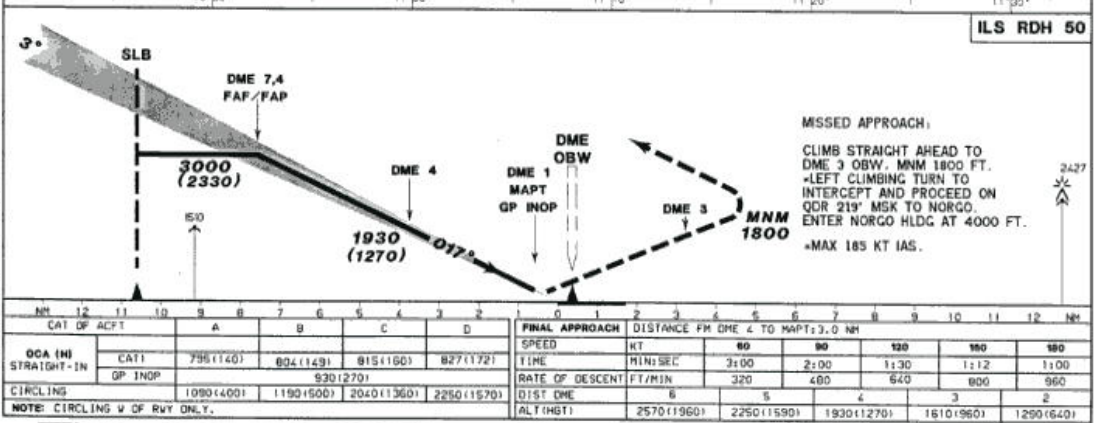
AD 2 ENGM 5 - 1

<b>INSTRUMENT APPROACH CHART-ICAO</b> T:275000		HGT RELATED TO THR OIL ELEV 656 FT. CIRCLING HGT RELATED TO AD ELEV 681 FT. ALTITUDE, ELEVATION AND HGT IN FT. BEARINGS ARE MAG.	TWR	APP	DIR	ATIS	<b>OSLO GARDERMOEN NORWAY</b> <b>ILS-01L</b>
			116.300 (123.325)	119.850 120.450	131.350	126.125 CLR 121.800 GND 121.675	
			TA 7000	VAR 1° W (1995)

CAT OF ACFT	A	B	C	D	FINAL APPROACH					
					SPEED	TIME	RATE OF DESCENT	DIST DME	ALT (HGT)	TIME
CCA (H)	795 (140)	804 (149)	815 (160)	827 (172)	60	3:00	320	4	2570 (1960)	11
STRAIGHT-IN					90	2:00	480	5	2250 (1590)	10
GP INOP		930 (270)			120	1:30	640	6	1930 (1270)	9
	1090 (400)	1190 (500)	2040 (1360)	2250 (1570)	150	1:12	800	7	1610 (960)	8
					180	1:00	960	8	1290 (640)	7

NOTE: CIRCLING W OF RVY ONLY.

Approach Control cleared FI-315 to 3 000 ft and informed the crew they could expect inbound turn on the localizer (LLZ) in 8 NM. At that point FI-315 was 10 NM from NDB SLB. The aircraft was slowed down to 220 KT, flaps were extended and landing gear was selected down. Almost overhead NDB SLB the crew received clearance to intercept the LLZ. The intercept angle was approx. 90°. Approach mode was selected on the Mode Control Panel (MCP). This late inbound turn caused a marked overshoot of the LLZ due to the limitations of the Autopilot (AP). The AP corrected to the left to intercept again. At this time FI-315 was cleared down to 2 500 ft and this altitude was set on the MCP. When the aircraft finally was established on the LLZ it was at least 1 dot high on the Glide Path (G/P). Flaps 20° was set with appropriate speed selection.

The descent and initial approach was made in strong tailwind. When established on the LLZ at 3 000 ft, the tailwind velocity was approx. 40 kt. The crew was not informed by the ATC about the strong tailwind on final. The wind on the ground was light from the North.
