# AIRCRAFT INCIDENT REPORT

Flugfélag Íslands hf.  
TF-JML, Fairchild SA-227-DC (Metro-23)  
Near Álftafjörður in Ísafjarðardjúp bay, Iceland  
16 August 1997

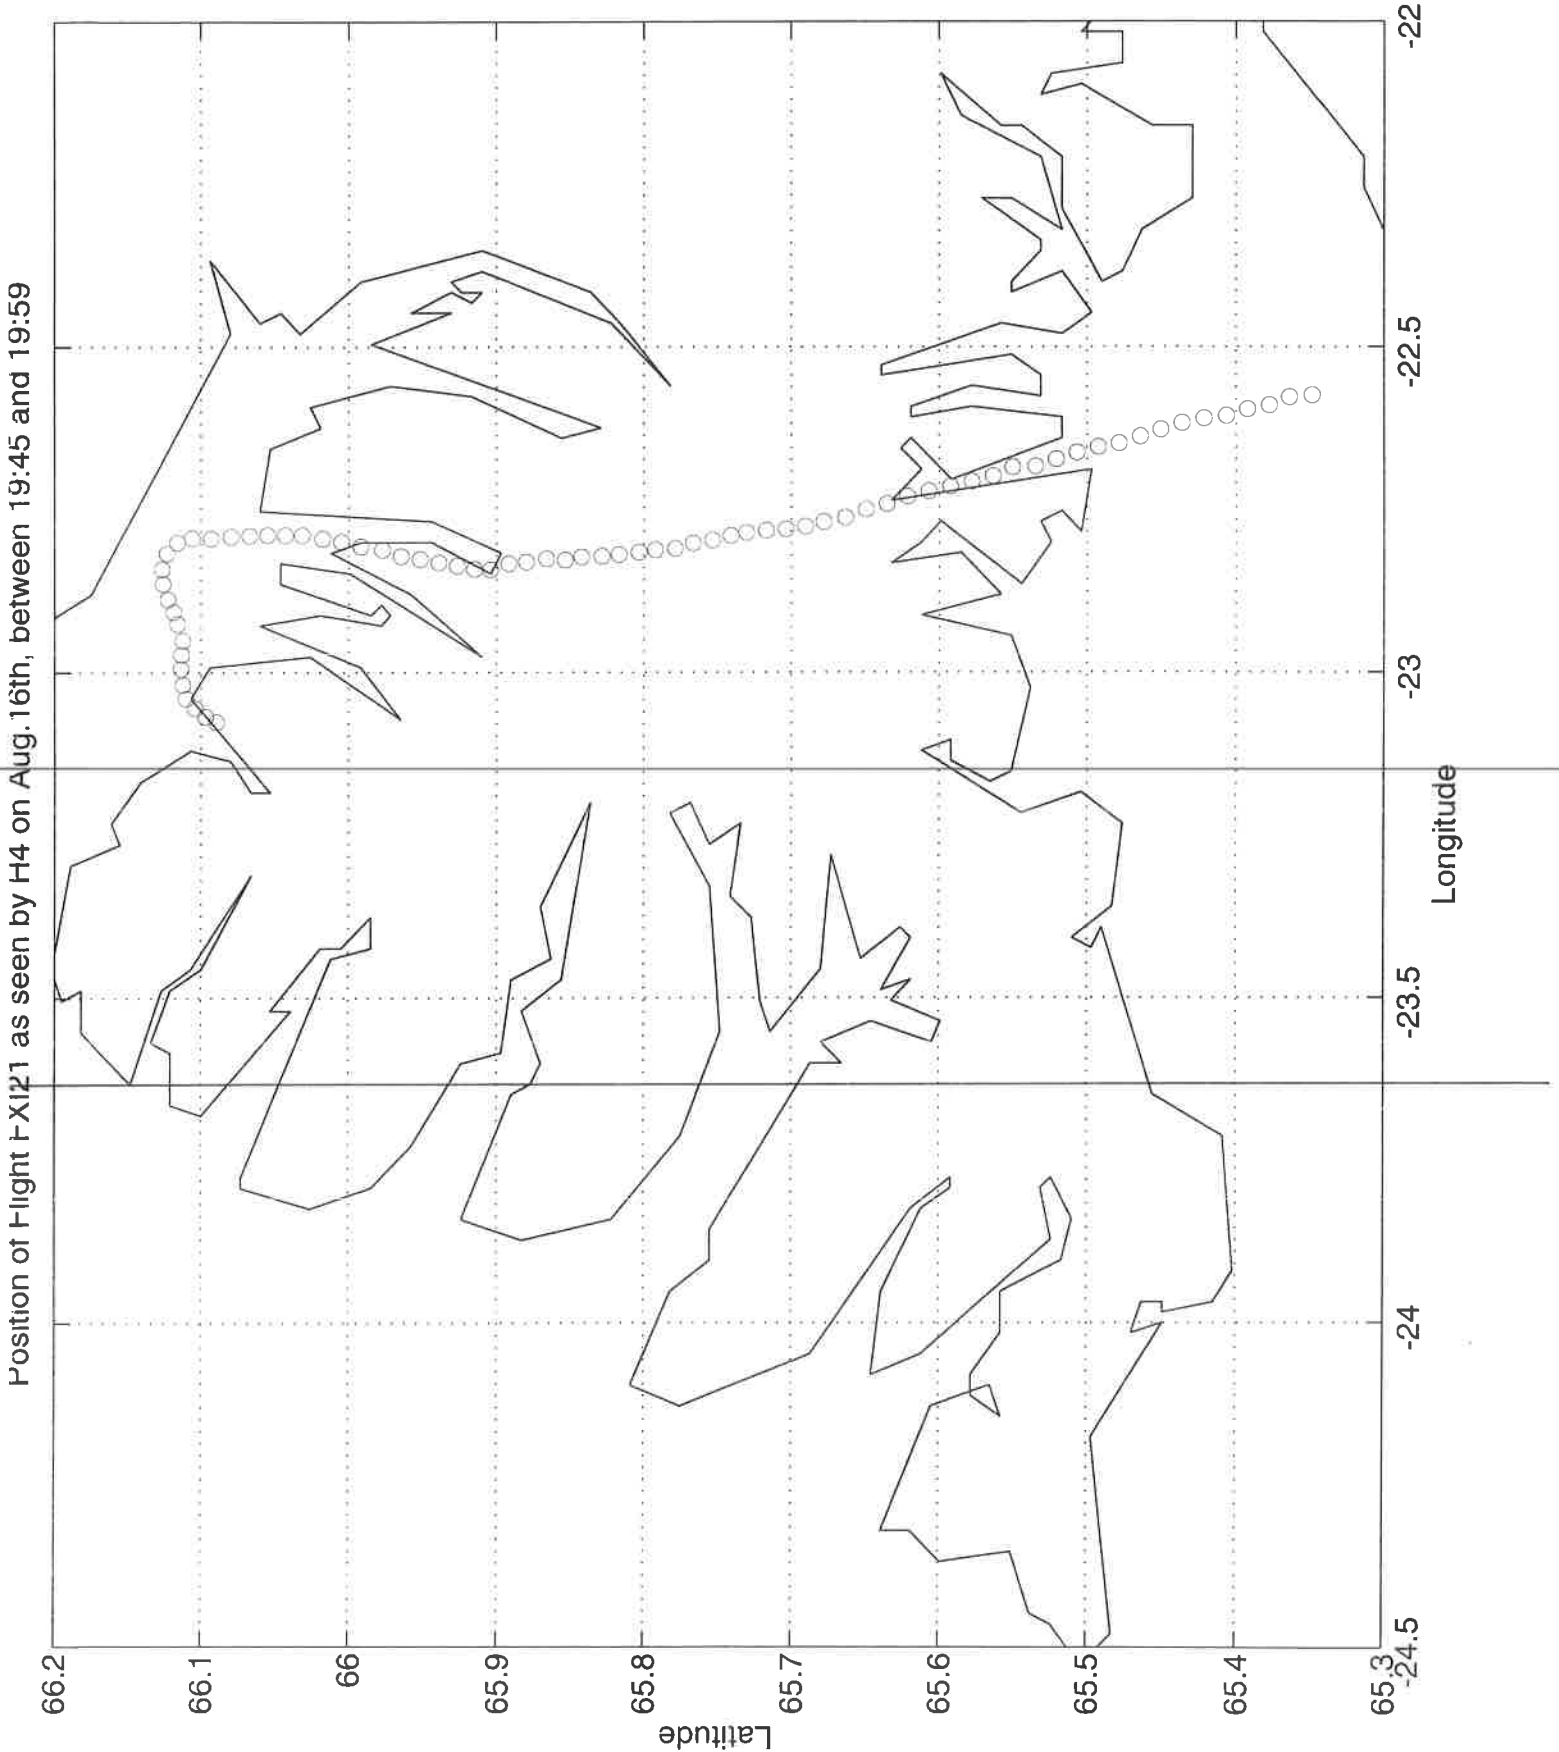
5.4 Map transcripts of the Bolafjall Radar data.

12 seconds between sweeps
